Passive thermography evaluation of bonding defects in adhered ceramic tiling: experimental and in-situ assessments

by J. Laranjeira*, N. Simões***, I. Simões*, A. Tadeu*** and C. Serra***

Abstract

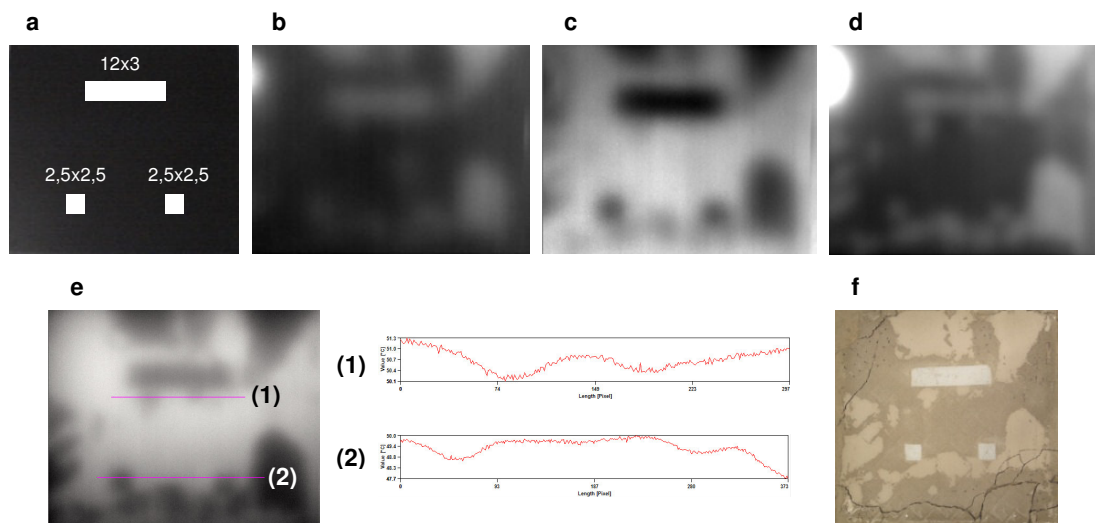
Figures 2b, c and d show the thermal response of the test specimen surface with the extruded polystyrene (XPS) defects obtained using the active thermography technique, while figure 2e shows the thermal response using a passive approach. Considering the schematic drawing in figure 2a, the majority of the induced defects (i.e. defects with a thickness of 3 to 4 mm between the adhesive layer and the substrate placed at an average depth of 2,3 mm for the rectangular defect and 1,9 mm and 2,4 mm for the squared figures (left and right, respectively)) are visible on the infrared (IR) images as shown by the contrasts achieved between defect and non-defect areas. However, additionally, non-induced defects are also detectable. After the ceramic tile was removed (figure 2f) the existence of air gaps between the adhesive layer and the ceramic tile with thicknesses of less than 1 mm was discovered, corresponding to the non-induced defects visible on the IR images.

Fig. 2. Test specimen with the extruded polystyrene (XPS) defects: a) schematic drawing (area defects in cm^2); b) raw thermal image from active approach; c) phase image obtained with pulse phase evaluation algorithm from active approach; d) amplitude image obtained with Lock-in harmonic approximation algorithm from active approach; e) thermal image from passive approach and surface temperature graphics from isotherm lines (1,2); and f) photo after the black ceramic tile has been removed.

Phase and amplitude images (figures 2c and d, respectively) resulted from the application of signal processing algorithms to raw thermal images (figure 2b) and it is visible that defect detectability was clearly improved. The phase image (figure 2c), that resulted from the application of the *pulse phase evaluation algorithm*, shows better contrasts between defect and non-defect area, then the amplitude image (figure 2d), that resulted from the application of the *Lock-in harmonic approximation algorithm*.

An analysis of some of the non-induced defects reveals that the air gaps immediately below the rectangular figure observed in figure 2f are more visible in the amplitude image than in the phase image. In the thermal image from the passive approach (figure 2e) those air gaps are also detected, as well as in the surface temperature graphic of isotherm line (1), where a significant surface temperature variation is shown on the defect areas.

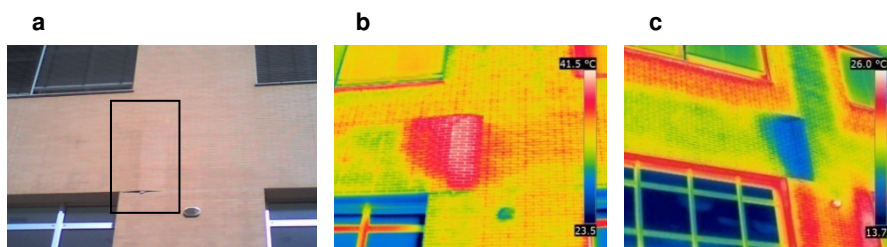
Figure 3 presents some photos and infrared (IR) images of a building facade with an unglazed ceramic tile cladding, facing West (building A), and without surrounding buildings nearby. Based on figure 3a, an adhesive failure and detachment of the adhered ceramic tiling (highlighted with a rectangle) is detectable. In IR images, the bonding defect is seen in the heating and cooling down periods (figures 3b and c, respectively), by showing a higher and lower surface temperature, respectively, than their surroundings. In IR image 3c, which resulted from the inspection performed during a cold period, the structural elements (i.e. columns and slab cross section) on the masonry are visible, which did not happened in IR image 3b (inspection performed during heating period).

Fig. 3. West facade of building A: a) photo of facade under direct sun radiation on April 8, 2014, b) thermal image of the surface under sun radiation from inspection performed with clear sky, that started at 4:00 p.m.; and c) thermal image of the surface from inspection performed with clear sky, that started at 8:30 p.m..

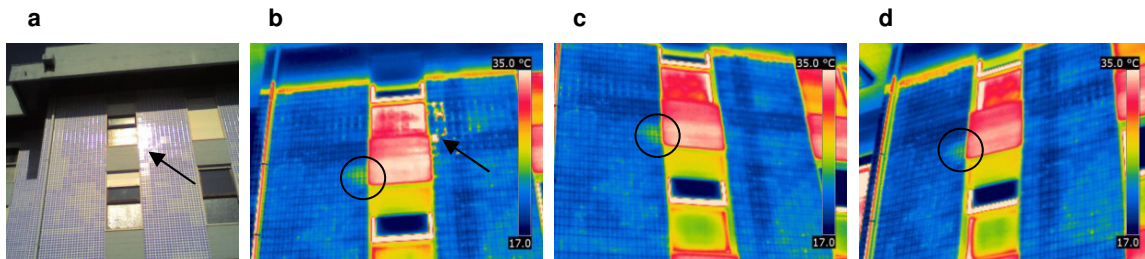
In another building inspection (Building B), a different thermal pattern (highlighted with a circle) is detected on the ceramic tile cladding, that is shown on the three IR images obtained with a perpendicular angle (figure 4b) and two opposite oblique angles (figures 4c and d) to building facade. Taking into account that the inspection on the building South-East facade was performed during the heating period (i.e. at 1:30 p.m. with clear sky), the suspicious area presents higher surface temperature than their ceramic tile surrounding on IR images. This thermal pattern may be caused by a bonding defect, however, according to figure 4a, the suspicious area does not present pathological evidences on their surface that may indicate the presence of a bonding defect. Other suspicious thermal patterns are also detected on the ceramic tile cladding. Therefore, in order to learn the thermal patterns behaviour of the possible bonding defects identified in figure 4, aimed at confirming the existence of bonding defects, more inspections were performed at several other times of day and with clear and cloudy sky conditions. Table 1 presents a set of IR image of each inspection performed to that particular area of the building B.

Fig. 4. South-East facade of building B: a) photo of the facade under direct sun radiation; b) thermal image of the surface from a perpendicular angle; c) thermal image of the surface from an oblique angle; and d) thermal image of the surface from the opposite oblique angle.

The thermal pattern highlighted with a circle on figure 4 (inspection started at 1:30 p.m.) are also detected earlier, at 10:00 a.m., during clear sky (different inspection days), both with higher surface temperature than the ceramic tile surrounding, as inspections were performed during heating period (building B in table 1). At 3:45 p.m., the thermal pattern is not detected when the building facade was already in the shadow of the nearby building (i.e. cooling period). Inspections performed at 7:30 p.m. and 9:00 p.m. evidence the thermal pattern, but showed a lower surface temperature (i.e. the cooling period continuous).

Therefore, this analysis reveals that it is quite possible that that area has a bonding defect filled with air. Confirmation could be achieved by performing a repercussion test that would require building a temporary structure, as this corresponds to a facade area between the second and the third floor.

In figure 4b (obtained from a perpendicular angle) visible some spots on the ceramic tile cladding with the higher surface temperature (i.e. the maximum of surface temperature scale) are pointed out. That area is also pointed out in figure 4a and it shows sunlight reflection, due to the perpendicular angle and glazed surfaces. Indeed, both images (figures 4a and b) resulted from the same perpendicular angle. However, in the IR image obtained, on another inspection, taken also from a perpendicular angle and during a heating period, but at 10:00 a.m. (building B in table 1) the sunlight reflection is not detected. This is probably due to a difference in sun direction, considering the different time of day.

The ceramic tile cladding shows changes in surface color patterns (figure 4a), the majority of which are also identified on IR images obtained from some inspections (figures 4b, c and d, and building B in table 1). Building users shared that a partial renewal of tiles had been performed in the past, which probably justify these thermal pattern changes. It is interesting to note that, the changes in surface color patterns of the ceramic tiles cladding are visible under direct sun radiation.

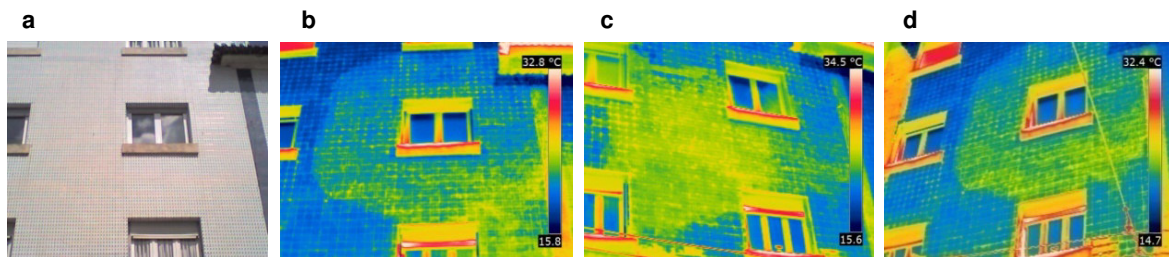
In a first inspection on the South-West facade of building C, a suspicious thermal pattern that may be the result of a bonding defect was found around a second floor window, in two of the three IR images obtained with different observation angles (figures 5b and d). The analysis of figure 5a does not reveal any superficial pathology that may be responsible for these thermal patterns behaviour. Furthermore, the building in front of the facade area under inspection is coated with a non-reflective yellow paint over a mortar layer. The inspection of this suspicious area of the building facade, performed at several times, and under clear and cloudy sky conditions (building C in table 1), demonstrated that the same thermal pattern is detected in the IR images, except for the IR images that resulted from 8:00 a.m. inspection with completely cloudy sky (i.e. before heating period). Furthermore, when detected, the thermal pattern always presented a higher surface temperature than that of the glazed ceramic tile surrounding, which may be due to a bonding defect.

Taking into account that the thermal pattern around that second floor window was detected with other inspection conditions (building C in table 1), in particular with similar observation angles as in figure 5c, the change of the thermal pattern around that second floor window with the observation angle (figure 5c) may be due to parked cars on the sloping and narrow street, as cars may reflect sunlight on glazed ceramic tile facades. Furthermore, the partially cloudy sky could also be responsible for that thermal pattern changes with the observation angle.

Fig. 5. South-West facade of building C: a) photo of the facade under direct and indirect sun radiation; b) thermal image of the surface from a perpendicular angle; c) thermal image of the surface from an oblique angle; and d) thermal image of the surface from the opposite oblique angle.

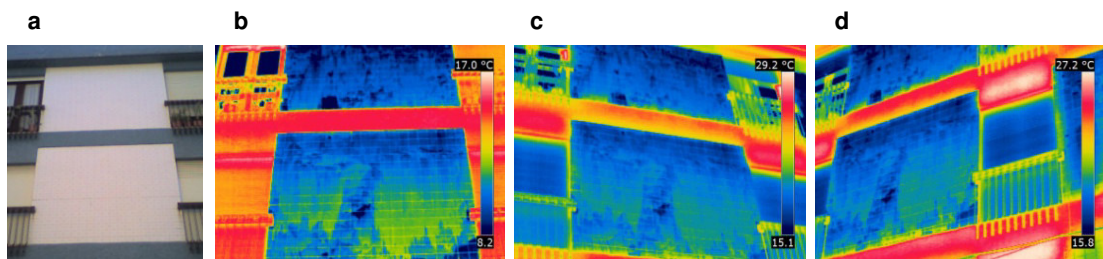
South-West facade inspections of building D evidence several areas of the ceramic tile cladding with a lower surface temperature (IR images in figure 6). These thermal patterns may be the result of heterogeneous areas in the support and not of bonding defects, since the inspection of this building facade area at several time of day and with clear and cloudy sky conditions, revealed that the suspicious areas were always detected with lower surface temperature than the ceramic tile surrounding. Moreover, at the beginning of the heating period with completely cloudy sky, the suspicious areas were less detectable. Additionally, the building facade does not show evidence of any superficial pathology (figure 6a).

Fig. 6. South-West facade of building D: a) photo of facade under their shadow; b) thermal image of the surface from a perpendicular angle (facade under their shadow); c) thermal image of the surface from an oblique angle (facade under direct sun radiation); and d) thermal image of the surface from the opposite oblique angle (facade under nearby building shadow).

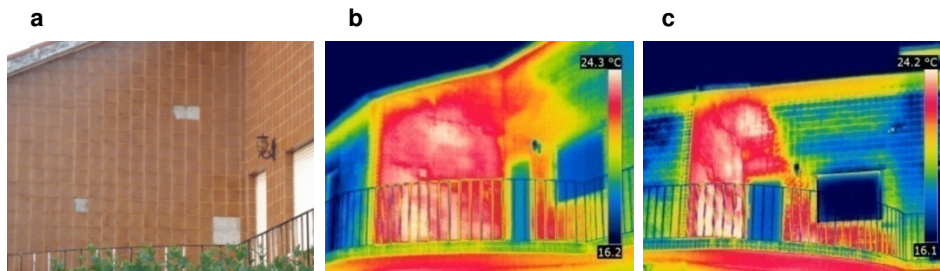
Figure 7 presents a particular case of a re-entrant corner inspection on the building E (South-West and North-West facades). Based on figure 7a three areas of adhesive failure of the adhered ceramic tiling are detectable. Those bonding defect areas are also visible on the IR images of figure 7. Moreover, along with them, a thermal path with lower surface temperatures connecting two adhesive failure areas (those located on underside of the facade) and

another path crossing the other adhesive failure area (at the top of the facade) are visible. Based on the fact that no building facade cracking was found on that area (figure 7a), probably those thermal paths are the result of bonding defects in the ceramic tile cladding. Furthermore, other areas of the ceramic tile cladding show higher surface temperatures, indicating that bonding defects may be gradually occurring.

Fig. 7. South-West and North-West facades of Building E: a) photo with three areas of adhesive failure of the adhered ceramic tiling on a re-entrant corner; b) thermal image of the re-entrant corner from inspection performed with clear sky, at April 10, 2014, that started at 10:00 p.m.; and c) thermal image of the re-entrant corner from inspection performed with partially cloudy sky at April 22, 2014, that started at 10:00 p.m..
