Applicability analysis of active IR thermography and selected signal processing methods for technical conditions assessment of bridge elements

L. Różański* and K. Ziopaja**

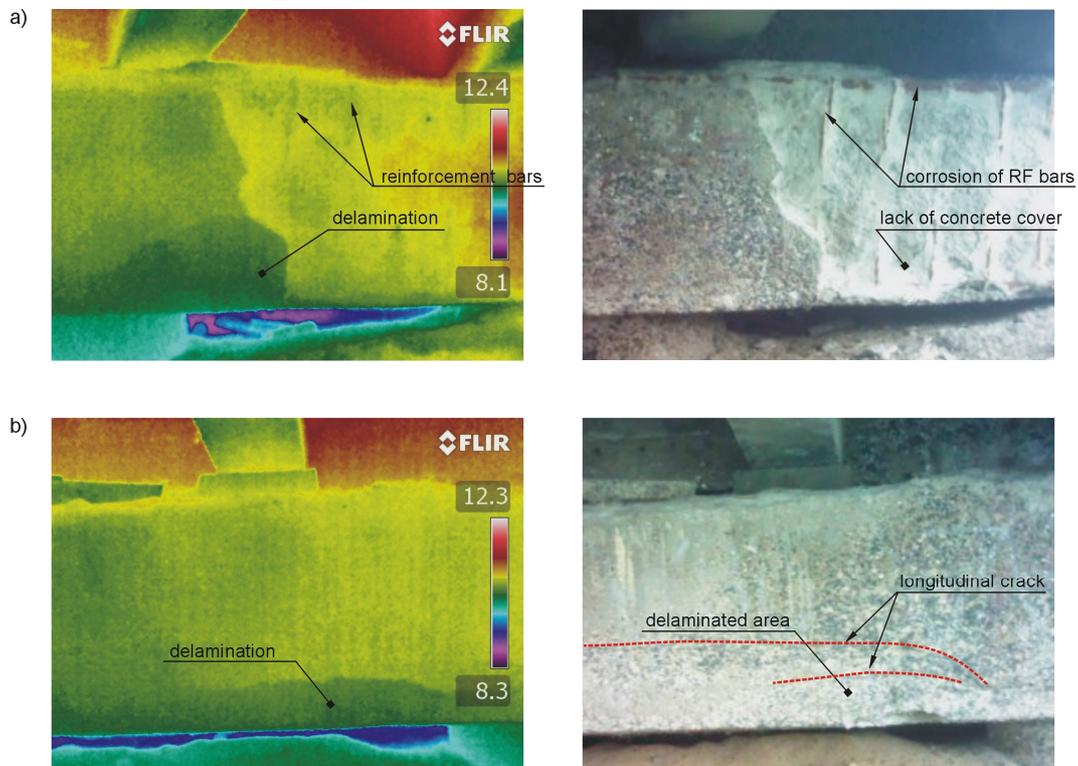
On the large vertical surfaces of the abutment cap some protective layer of concrete fell off. On other areas there are shortages of adhesion of this layer. There is also a lot of visible flaking of concrete. It was probably caused by

corrosion of reinforcement, small thickness of the cover layer (1.5 cm for stirrups and 2.5 cm for main bars), carbonation and chemical corrosion of concrete. In the neighbourhood of longitudinal bars of the cap (both top and bottom) there are longitudinal cracks of different length. The causes must be similar to the abovementioned ones.

Fig. 3. Passive IR-thermography test results of RC abutment cap:
 a) infrared image and photo of the extreme section
 b) infrared image and photo of the intermediate section

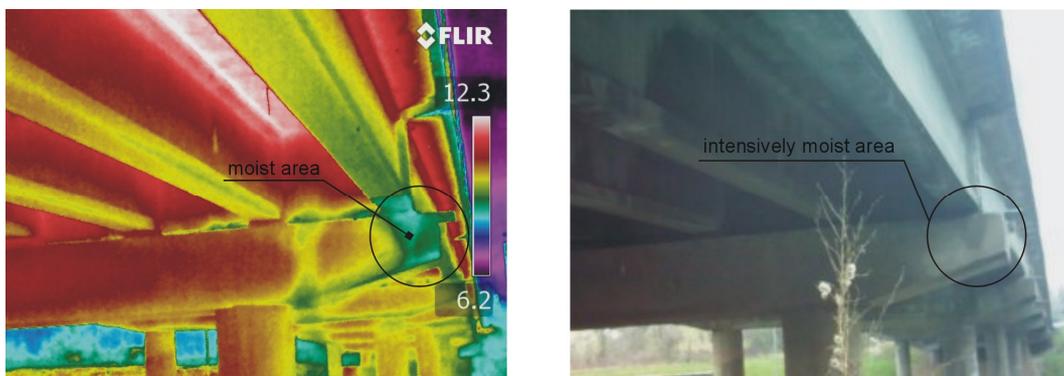
The intermediate pier is in far better technical condition than the abutment. There are less cracks and they do not seem to be so intense. Only in the section near the expansion gap between two adjacent spans some intensely wet and degraded areas of concrete have been noticed. Due to lack of integrity and leakage of the surface, water flows on the edges of girders and reaches the end of the capping beam. Such long-term state leads to chemical corrosion of concrete and the occurrence of corrosion in reinforcement, leaching corrosion of concrete, which can weaken seriously the endangered sections of the support. It is noted that many places of delaminations of the concrete cover, intensive spalling and large losses or cracking of concrete have recently been provisionally repaired.

Fig. 4. Passive IR-thermography test result of intermediate RC pier cap: infrared image and photo

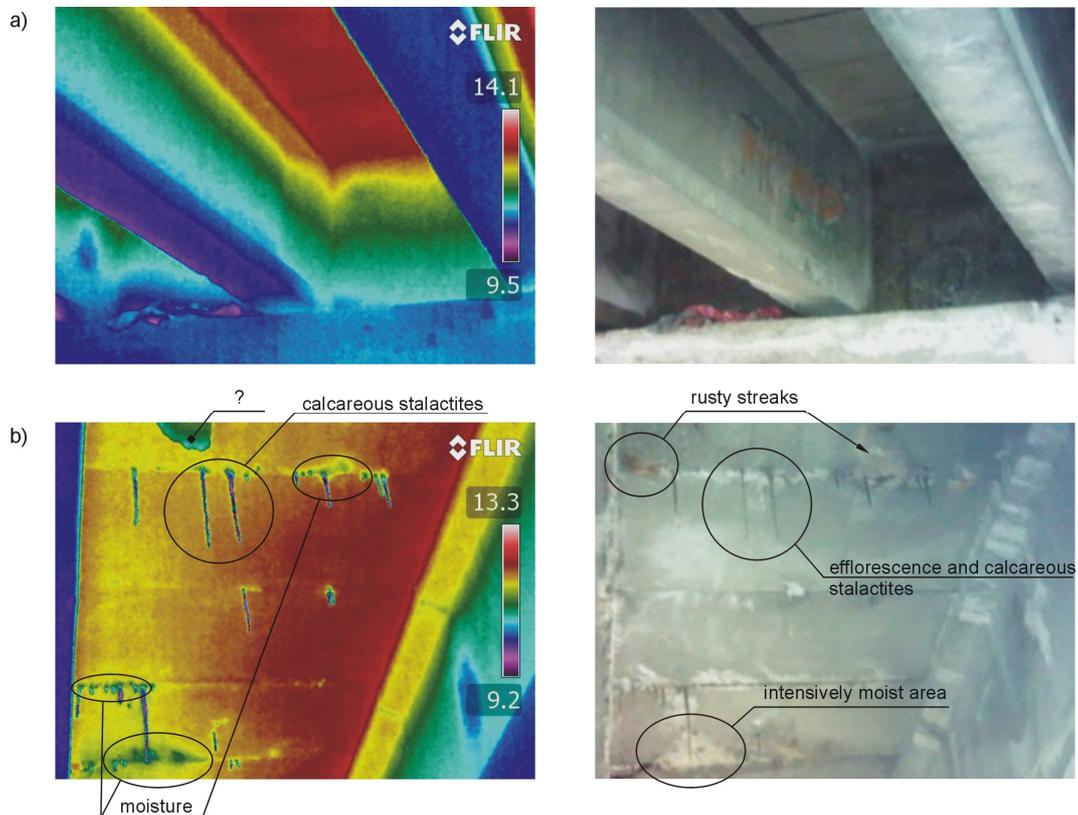
The observation of bottom of the plate with the use of an infrared camera in the dry areas has shown temperature uniformity without any disruptions. However, in many areas where the insulation of the plate is in a critical state, some wet places, runs and efflorescence along the cracks in precast concrete slabs extending toward the main girders are visible. The penetration of water seems to be so intense and long-term that some stalactites have been formed. It proves the intensity of leaching and chemical concrete corrosion. Numerous rusty streaks inform about strong corrosion of reinforcement of precast concrete slabs (nevertheless, there are no cracks or delaminations in the covering layer of concrete). The examples of the abovementioned damages are shown in Fig. 5b.

Fig. 5. Passive IR-thermography test results of the underside of deck slab:
 a) infrared image and photo of the section in satisfactory condition
 b) infrared image and photo of the section in serious condition

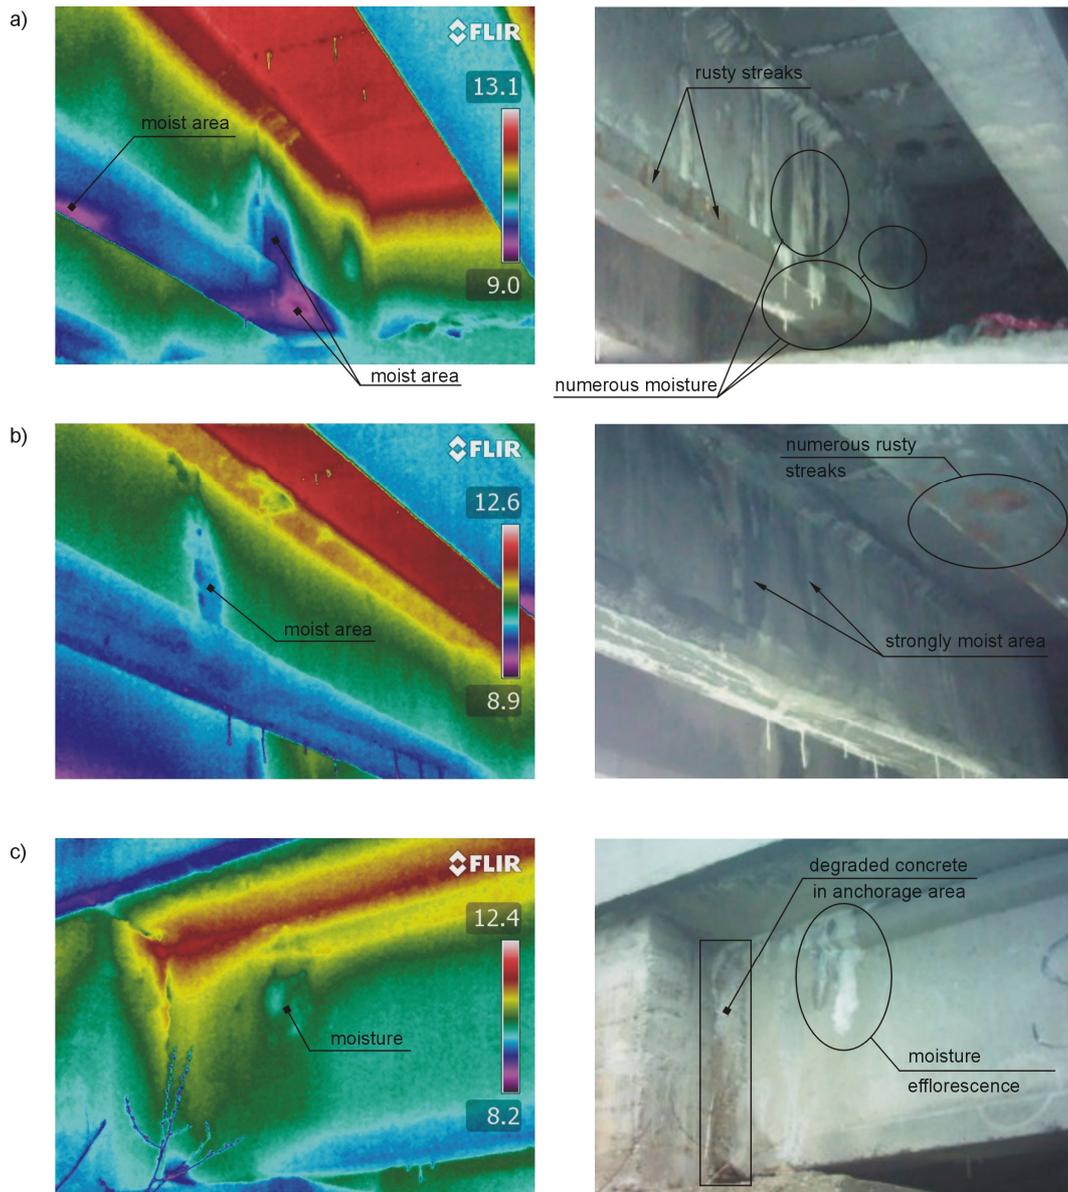
Damages of the girders may be divided into two groups. The first group of damage threatens the safety of the structure and the second group decreases durability and worsens aesthetic. The first group includes corrosion of prestressing strands, corrosion of the anchor blocks and degradation of concrete in the immediate area of the anchor blocks. Observed on the underside of girders rust-colored streaks and losses of concrete cover (Fig. 6a, b) are the best evidences of advanced corrosion. Unfortunately, passive IR thermography can not give any answers about the condition (state) of prestressing steel bars. Poor condition of the concrete anchorage zone tendons (Fig. 6c) also can not be verified by means of passive thermography. Passive thermography can help only in assessment of the moisture degree and area of tested concrete surface.

Fig. 6. Passive IR-thermography test results of the prestressed I girders:
 a,b) infrared image and photo of two different WBS type beams
 b) infrared image and photo of external I girder at the abutment
