## **Infrared Thermography and X-Ray Tomography for Non-Destructive Evaluation of Micro-defects in CFRP**

by H. Zhang\*, W. Holub\*\*, H. Fernandes\*, U. Hassler\*\*, S. Joncas\*\*\*, F. Robitaille\*\*\*\*, X. Maldague\*

### **Abstract**

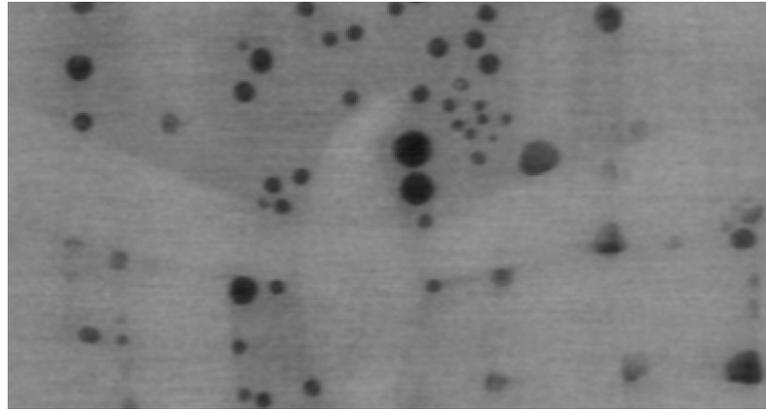
**Fig. 3.** X-Ray tomography inspection result

The high resolution X-Ray tomography inspection was conducted in this work to detect the interior structural defects of the tested sample. The resolution used for the test is 20 microns. Fig. 3 is the X-Ray tomography inspection result.

Plenty of micro-porosities were identified in the X-Ray tomography inspection result. Most of them have a diameter of approximately 0.1mm. Some have a slightly larger diameter of 0.2mm or more. The inspection result is visually extremely clear.
