# Quantification of Voids and Delaminations in Real Concrete and Masonry Structures with Active Thermography: Case Studies

by Ch. Maierhofer\*, R. Arndt\*, M. Röllig\*, R. Helmerich\*, A. Walther\*\*,  
B. Hillemeier\*\* and C. Rieck\*\*\*

\*Federal Institute for Materials Research and Testing (BAM), Berlin, Germany

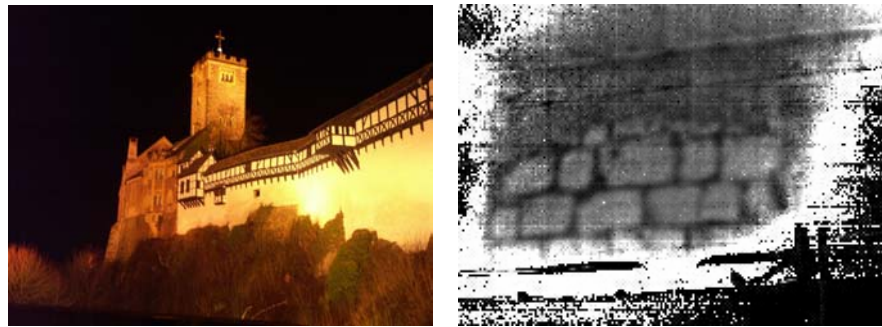
**Fig. 1.** Left: View of Wartburg in Eisenach, Germany. Right: Phase image at  $f = 2.46 \times 10^{-4}$  Hz recorded with pulse phase thermography showing the walled door behind the plaster at the Landgrafenzimmer of the Wartburg.

The aim of the investigations with impulse-thermography was to localise this former door opening. The investigated area was about 3.5 m in horizontal and 1.2 m in vertical length and was located above a showcase. Each square meter of this area was heated up with a fan heater for about 5 min. Afterwards, thermograms were recorded with a frequency of 2 Hz for about 15 min using the above described infrared camera. After data recording, PPT was applied for data analysis. A phase image at a frequency of  $f = 2.46 \times 10^{-4}$  Hz from a section with a width of about 1 m is displayed in fig. 1 right. It clearly shows the masonry and mortar structure in the

lower part of the wall with an arc-shaped boundary on its upper part, which corresponds to the shape of the walled-up door. In the upper part of the wall no masonry-structures are visible. More information about the investigations at Wartburg is published in [14].

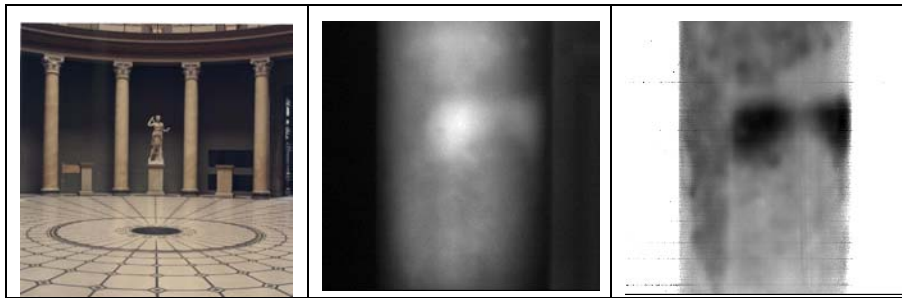
**Fig. 3.** Left: Rotunda of the Altes Museum with plastered sandstone columns  
Middle: Thermogram at a selected area after 5 min heating. The temperature range was scaled from 20 to 30 °C. The delamination appears as white area (high temperature). Right: Phase image of the same area at  $5.56 \times 10^{-4}$  Hz. The delamination appears as dark area.

The columns in the rotunda belong to the original asset from 1830 (see fig. 3 left). The columns consist of massive sand stone, which is covered with lime plaster

having a thickness of 2 to 3 cm. This plaster is the carrying layer for the visible stucco marble layer of 3 to 6 mm. The sand stone core is massive and it was revealed with radar that it consists of single drums [15]. The whole surface of the columns is covered with a net of small cracks. The cracks are very thin, but few of these have a width of up to 2 mm. By knocking on the surface, different types of delaminations can be assumed: Delaminations of the stucco marble layer, delaminations of the plaster and a combination of both. One column had been selected for investigations with impulse thermography to locate and quantify these delaminations. Again, for the heating of the surface of the columns a conventional electric fan heater has been used with a heating power of 2000 W avoiding temperatures at the surface higher than 50 °C. Each section of the column with a height of 1 m was heated for about 5 min. For accessing all parts of the column, a lift was used. Large areas with delamination appear in the images of the lower parts of the column as demonstrated in the warmer part of the thermogram in fig. 3 middle and in the dark parts of the phase image at  $5.56 \times 10^{-4}$  Hz in fig. 3 right. From comparisons with results obtained at test specimens with different mortar thickness in the laboratory [16], it is assumed that these delaminations belong to the stone/mortar interface.

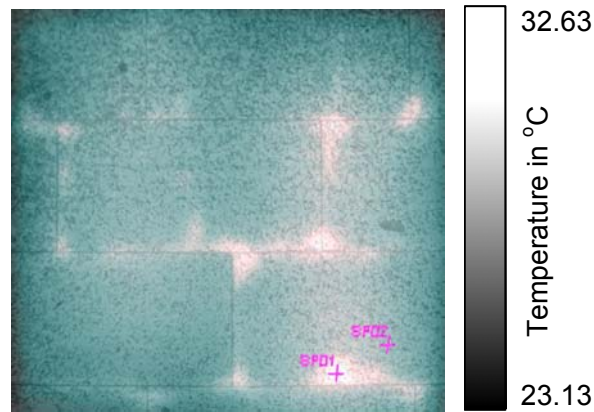
**Fig. 4.** Superpositioning of an equalised digital photo and the related equalised thermogram of several granite tiles ( $1 \times 1 \text{ m}^2$ ) recorded after a heating time of 3 min. The voids could be clearly detected as warmer (white) areas.

For the detection of voids below a stone pavement consisting of granite tiles with a thickness of 1.5 cm, which were laid on mortar on a concrete floor, a whole area of 40 m<sup>2</sup> was investigated. Single areas of about 1 m<sup>2</sup> were heated up with an infrared radiator for about 3 min. The cooling down behaviour was recorded with the infrared camera. The voids could be easily detected with a temperature difference of about 2.5 K as shown in fig. 4. Here, the superpositioning of the photogrammetric equalised digital photo as well as of the equalised thermogram recorded 1.33 min after switching off the heating source is displayed. From the photo, the position of the joints can be clearly derived which shows that the main voids appear at the edges and sometimes also along the joints of the tiles.

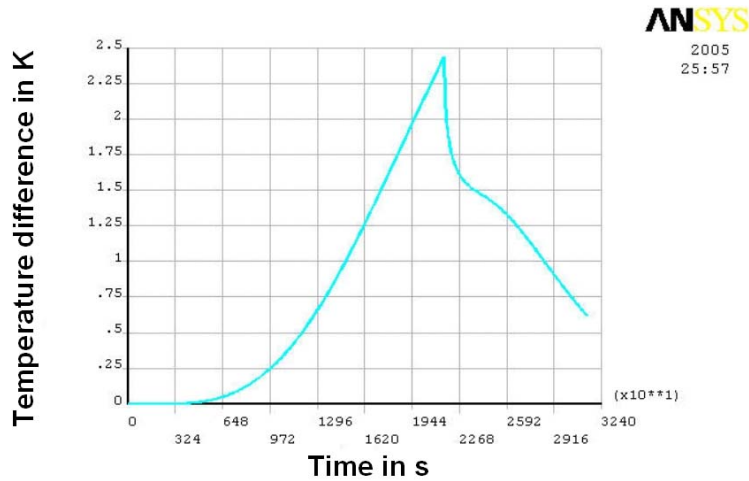
**Fig. 5.** Simulated temperature difference as a function of time for an asphalt layer with delamination and the sound area.

For the location of voids and delamination under asphalt, also the sun can be used as heating source to generate a non-stationary heat transfer. For assessing the expected temperature difference of a delamination and the optimum time for data recording, numerical simulations were performed by Finite Element Modelling with ANSYS. At the beginning of the simulation, the temperature of the structure was set to  $10 \text{ }^\circ\text{C}$ . The applied heat radiation was varied by linear increase from 0 to  $300 \text{ W/m}^2$  for about 3 h, afterwards the radiation was kept constant at  $300 \text{ W/m}^2$  again for a duration of 3 h. As a structure, a concrete plate with a thickness of 30 cm covered by an asphalt layer with a thickness of 7 cm was assumed. Between both layers, a 1 mm bitumen sheet was positioned. As a defect, a  $20 \times 20 \text{ cm}^2$  delamination of the bitumen sheet was assumed. As a result, the difference curve of the temperature above the delamination and above the sound area is displayed as a function of time in fig. 5. A maximum temperature difference of about 2.5 K is obtained after a heating time of about 5.7 h. Therefore, the sun seems to be suitable as heating source for the detection of defects in and below asphalt layers by measuring the temperature distribution at the surface with an infrared camera.

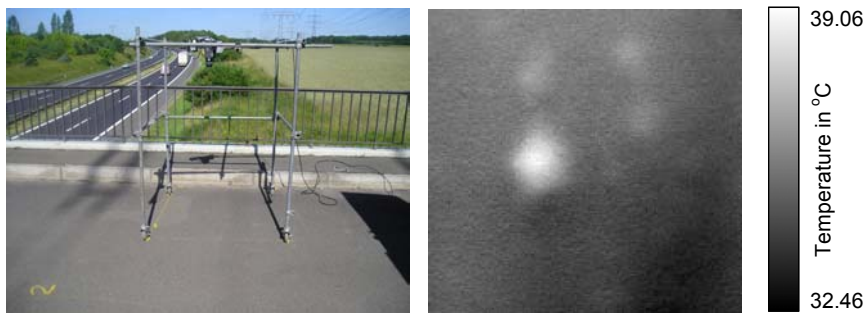
**Fig. 6.** Left: Small scaffold at the bridge with the mounted IR camera. Right: Thermogram recorded at 10 a.m. summer time, 2005-06-23, sun, in Berlin of a 1 x 1 m<sup>2</sup> sized area of an asphalt layer on a concrete bridge. The delaminations are clearly shown as warmer areas.

On-site-investigations on a pre-stressed concrete bridge were carried out for the detection of voids or delamination inside or below the top asphalt layer. The paving above the concrete plate consisted of up to 50 mm concrete for levelling, 10 mm mastic for sealing and an asphalt layer with a thickness of 50 mm. Thermal images were taken at varying times after sunrise, thus using the sun as a heating source. For performing the measurements, a small scaffold was installed (see fig. 6 left) enabling the positioning of the camera and having the possibility of shadowing of the area under investigation for avoiding the incidence of direct and reflected sunlight.

Fig. 6 right shows a thermogram taken at 10:00 a.m. at a measured solar radiation of  $800 \text{ W/m}^2$ . Clearly distinguishable are areas of higher temperature, which might be related to defects or delamination. The largest of these areas in the middle of fig. 6 right has a temperature difference of 3.5 K to its surrounding.

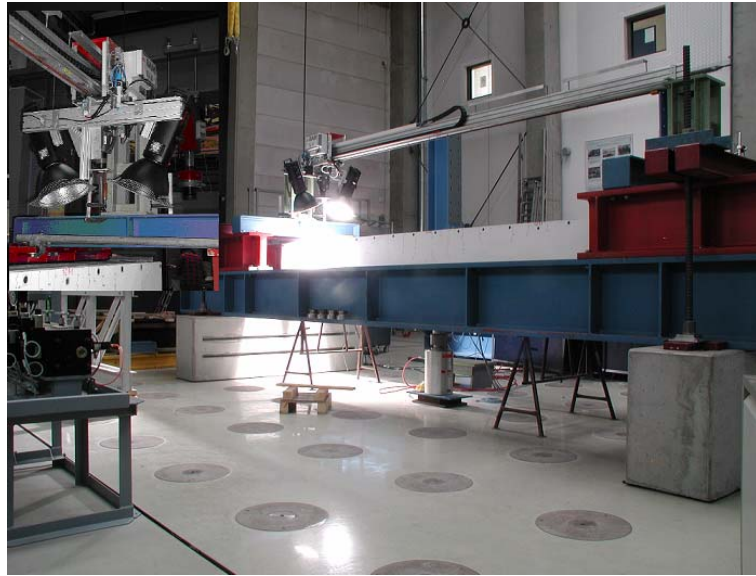
**Fig. 7.** Strengthened concrete beam during four point bending test with the thermographic scanner system showing the flash lights and the scanner axis.

For on-site applications enabling automatic testing along large ranges, thus a new scanner system was developed consisting of flash lights as heating sources (1500 W each) as shown in fig. 7. For optimising and testing of this system, a reinforced concrete beam with a size of 0.3 x 0.5 x 5.2 m<sup>3</sup> was constructed. In close cooperation with the laboratory for Structural Engineering at the Potsdam University of Applied Sciences, the beam was preloaded in a four point bending test with a

maximum applied load of 100 kN, where flexural cracks of about 2 mm developed. The load was applied from underneath the beam, thus the thermography test set-up was chosen top-down for avoiding spalled concrete parts damaging the thermocamera and the heating unit.

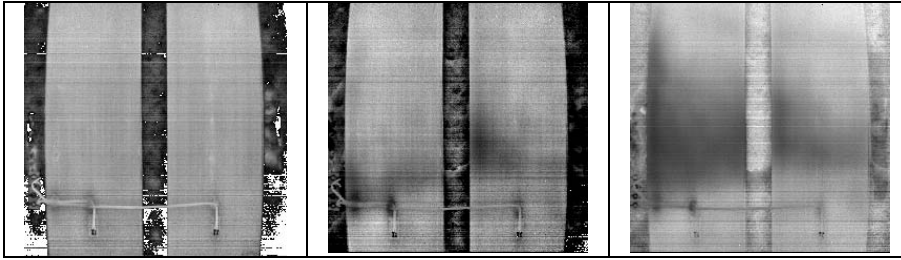
**Fig. 8.** Phase images at a frequency of  $3.33 \times 10^{-3}$  Hz recorded after a load of 180 kN (left), 285 kN (middle) and 295 kN (right).

The 1/3 points of the beam length turned out to be the weakest cross sections in shear. The failure emerged immediately, after new shear cracks propagated at about 5% below ultimate load (295 kN). The CFRP-plate debonded at the superposition of flexural and shear cracks. In fig. 8, three phase images recorded at  $3.33 \times 10^{-3}$  Hz are shown after a load of 180, 285 and 295 kN, respectively. After a load of 180 kN, a homogeneous phase distribution is shown giving no hints to unintentionally included delaminations. First inhomogeneities in the phase images can be observed after a load of 275 kN, which became more clear after a load of 285 kN displayed in fig. 8 middle. After a load of 295 kN, in 1/3 of the beam length the rod was completely delaminated along the cross section. In the related phase image in fig. 8 right, complete delamination can be detected.
