Assistance to the restoration of historical frescoes by stimulated infrared thermography

by J.C. Candoré*, J.L. Bodnar*, V. Detalle** and P. Grossel*

Abstract

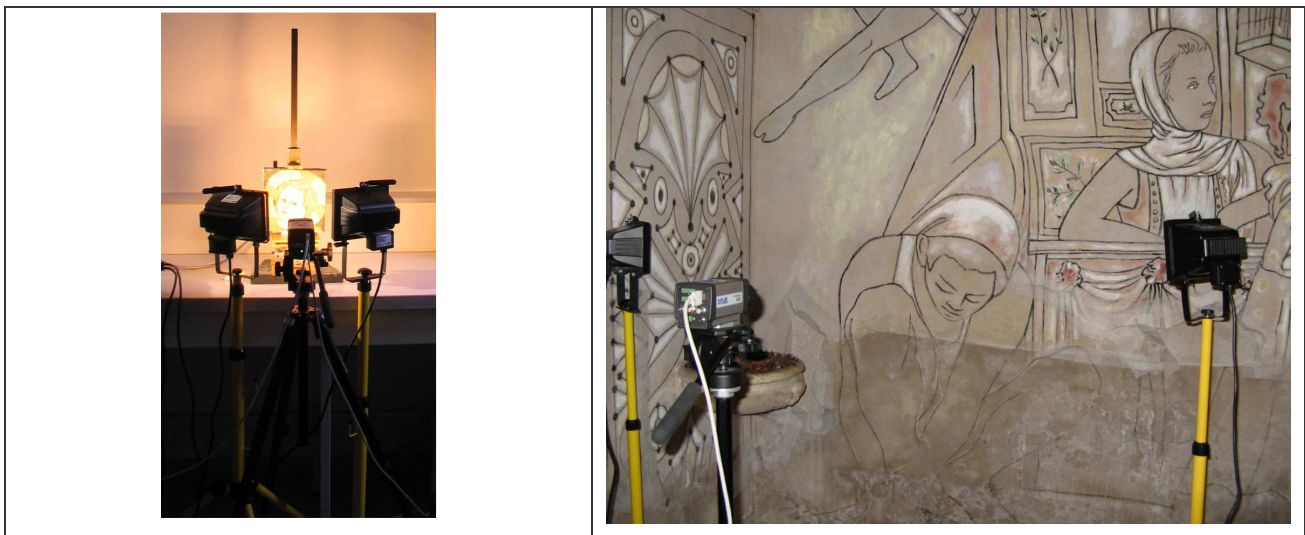
Fig. 1. The experimental device used

So, we chose projectors with industrial halogens to excite in an impulsive way, mural paintings to be analyzed, a camera of infrared thermography (for example of type A20 from FLIR) to assure the collection of the information and finally an electronics and a computing of piloting of the instrumentation allowing a photothermal analysis (fig. 1.).

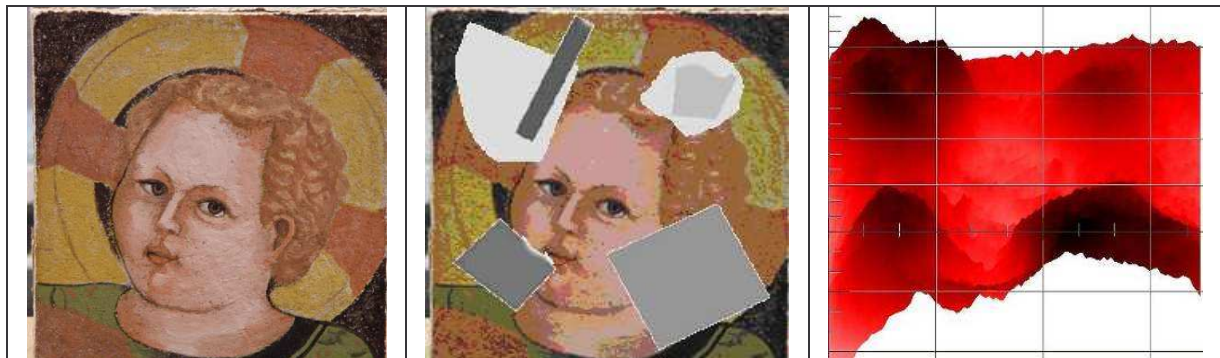
Fig. 2 . The fresco studied (left), the position of the internal defects (center) and the three-dimensional infrared photothermal image obtained (right)

The first type of mural painting we analyzed is a partial copy of the Saint Christopher of the "Campana" collection of "Louvre". It acts, as shows in the fig. 2a of a fresco realized according to the technique of primitive Italian, in a mixture of lime and plaster, the whole being covered with a pictorial layer, which represents here the infant Jesus.

This fresco, realized initially as sample of pre-study with the aim of the analysis of the "saint Christopher" itself, contains 4 defects: 4 inclusions of "plastazote" (fig. 2b).

To detect these defects, we analyzed this fresco by stimulated infrared thermography. An example of result obtained is presented on the fig. 2c. It clearly shows a more important infrared signature towards the defects. These characteristic signatures are due to the more insulating thermal properties of the "plastazote" with regard to the mixture lime / plaster. Indeed our operating mode consists in exciting our sample with the visible light. This light, during an interaction radiation / material warms slightly the surface of the work of art. This heating propagates then by conduction in the fresco. Towards the defects, constituted essentially by air and thus more insulating thermally than the mixture lime / plaster on which was put deposited the pictorial layer, this distribution was slowed down. It follows itself a less fast cooling of the surface enlightened in the right of the defects and thus an infrared signature more important for this location.

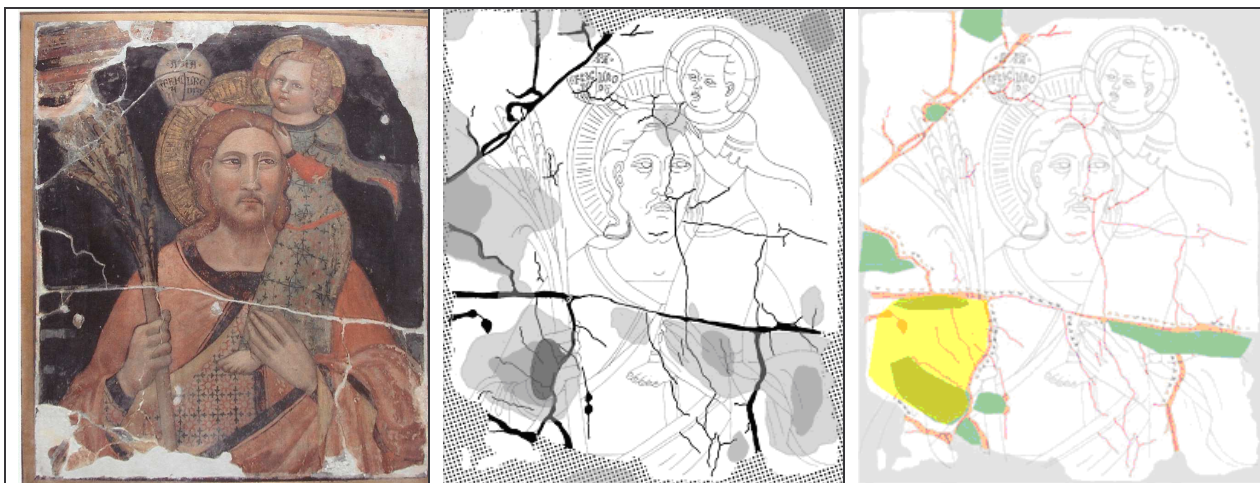
Fig. 3. The fresco of Saint Christopher studied (left) and the experimental results obtained during the acoustic analysis (center) and photothermal (right)

The results were obtained on the test fresco being encouraging and effectively non-destructive, we analyzed secondly the “Saint Christopher” itself. This work of art represents “Saint Christopher” carrying the infant Jesus and is attributed to “Tommaso del Mazza”. It was created between 1385 and 1390. It is a part of the “Campana” collection of “Louvre” (fig. 3a). This fresco was analyzed at first in an acoustic way by Gabriella Szatanick, restorer of the heritage. We then analyzed it, area by area, to obtain a sufficient optical resolution for each image, by pulsed photothermal radiometry. The obtained results are compared on the fig. 3c to those obtained by acoustic analysis (fig. 3b). On this figure, we notice on one hand, that the characteristic signatures of visible defects by photothermal radiometry (green and yellow areas) correspond to areas of detachment detected by the acoustic method (grey area). We notice on the other hand, that in the conditions of implementation of the photothermal method (pulsed excitation of 2 minutes duration), the defects detected by the photothermal method are less many than by the acoustic method. Apparently, it is due to duration of too short excitation, not allowing the detection of the deepest defects (example of the defect situated above on the right by the mural painting). We have still noticed, experimentally, that the defects detected at the same moment by photothermal radiometry, gave birth to the same tone by acoustic sounding, what confirms that they had to be approximately situated in the same depth. The photothermal analysis thus seems to open the way to a dimensional characterization of the defects, difficult by acoustic way. Finally, we verified that the acquisition of information by photothermal radiometry is certainly effectively faster and more objective than the acoustic analysis.

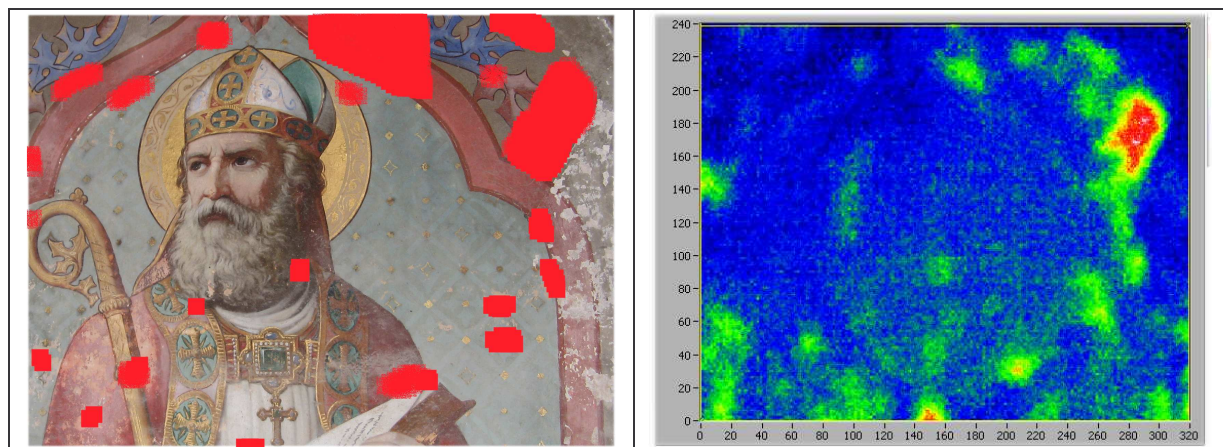
Fig. 5. The experimental results obtained during the acoustic analysis (left) and photothermal (right).

We have first of all and as in the previous cases, analyzed this painting mounted on canvas in an acoustic way. The statement obtained makes appears a multitude of "hollow" tones, restarted rather in periphery of the work of art (fig. 5a). We then analyzed this painting mounted on canvas by pulsed infrared thermography and continuous detection (excitation of 5 minutes). An example of result obtained is presented on the fig. 5b. It shows more important, significant photothermal signatures of the presence of defects, in locations referenced by the acoustic analysis.

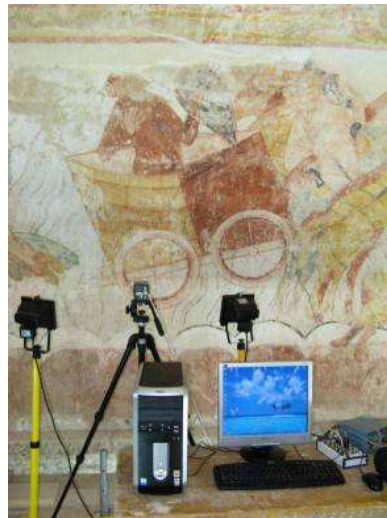
Fig. 7. The mural painting studied, "*La traversée du désert*"

Several campaigns of restoration of mural paintings took place. The first one was realized by "Prosper Mérimée" in 1835. In 1967 a second campaign of restoration aimed the paintings of the narthex, the vaults of the nave and both crypts. Finally, since 2005, a new campaign of restoration of the paintings of the nave began. It is in this frame and as a supplement to the acoustic statements made by restorers' team working on the construction site ("Brice Moulinier", "Emmanuelle Cante") that intervenes our study. This last one aimed on one hand at confirming, even at completing the statements of the restorers. It also had for objective to test the possibilities of the stimulated infrared thermography in real conditions of restoration (on a scaffolding, in the dust, in the cold, at the same time in the other types of analyses, at the same time as works of restoration, in a limited time). The mural painting we studied is a part of the fresco of the "*La traversée du désert*", more particularly the zone surrounding the back wheel of the char (fig. 7.).

The statement made by the professional restorers is presented on the fig. 8a. It makes appear abnormal acoustic signatures in the lower and superior parts of the wheel of the char. We then analyzed this fresco by pulsed photothermal analysis. An example of result obtained is presented on the fig. 8b. This last one shows more important, significant photothermal signatures of the presence of defect, in location referenced by the acoustic analysis: in low and high parts of the wheel of the char. However in the case of the photothermal analysis, these two signatures are not uniform but seem to indicate the presence of two separate defects, while the acoustic analysis had detected only one. A new acoustic statement

made by restorer's team then confirmed the presence of two separate defects in both cases. The photothermal method thus seems to allow a detection at once, more precise of the position of the defects, than the acoustic method. These images also show that the photothermal method seems to be able to be implemented, in situ and in real conditions of restoration.

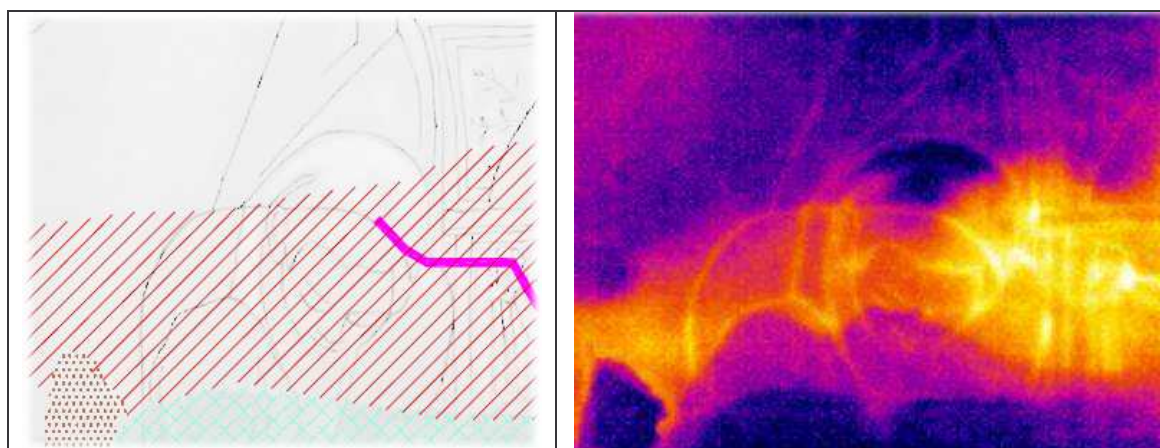
Fig. 11. Experimental results obtained during the acoustic (left) and photothermal (right) analysis of the mural painting "Hommage aux pêcheurs de Sainte Marie"

As regards the part of the mural painting studied, the restorers (fig. 11a) detected an important partially central detachment of the fresco (red hatchings), a fall of the filler supporting the lower left pictorial layer of the work of art (purple dot) and finally on the straight part of the drawing, a band of Japan paper to strengthen the same filler, certainly more altered in this place (purple line). The object of the photothermal analysis was in this fifth study, on one hand to try to confirm the acoustic statement. It was necessary on the other hand, in real conditions, to try to improve the precision of the rather unrefined acoustic statement. It was finally necessary to confirm again, the possibilities of the infrared thermal imaging stimulated in detection in situ of defects situated in mural paintings.

An example of photothermal image pulsed obtained is presented on the fig. 11b

It confirms at first the results obtained by acoustic analysis, that is a detachment seems good to exist in the analyzed area and that is a lack of filler is detected in the left bottom of the work of art.

It then seems to show a finer statement of the outline of this area of detachment, than the acoustic analysis, what presents certain interest for the restorers of the heritage.

It finally shows a more important photothermal signature to the right of the infrared thermogram, in the location or was put by some Japan paper to strengthen the work of art (thus locally more fragile).
