Comparison of the defect detection capabilities of flash thermography and vibration excitation shearography

By S. G. Pickering* and D.P. Almond*

Abstract

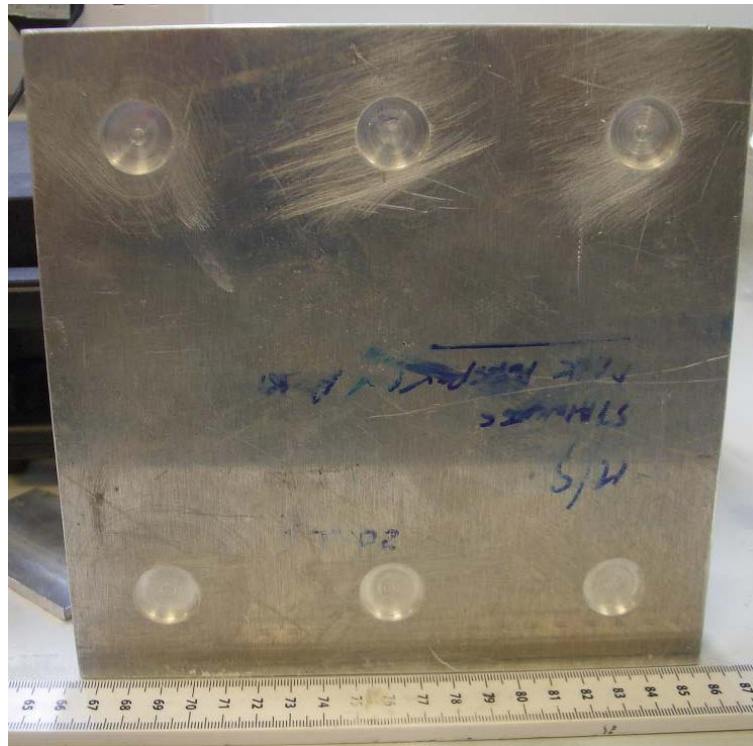
Fig 1. Aluminium test sample with 20mm \varnothing back-drilled hole defects at depths from 0.5mm to 3mm (0.5mm to 1.5mm top left to right, 2.0mm to 3.0mm bottom left to right)

To enable a comparison of the techniques, a set of test samples were manufactured. These samples are square flat plates of side length 200mm made from aluminium, mild steel, stainless steel, CFRP and thermoplastic. Back-drilled holes of 20mm diameter and varying depths were drilled in the samples to represent defects. The defect depths (i.e. material remaining after back-drilled holes were created) ranged from 0.5mm to 3mm in steps of 0.5mm. The back surface of the aluminium test sample is shown in figure 1, below. Note the large space left in the centre of the sample to allow the piezoelectric transducer to be affixed in the centre.
