STUDY IN MECHANICAL FAULT ELEMENT THERMOGRAPHY THROUGH THE MACHINE: The case of deep groove ball bearings of a career without screen.

by Francisca C. da Silva¹, Juscelino F. Maribondo², Antônio S. Almeida³, Tadeu C. da Silva⁴, Richard Senko⁵

The objective of this study is to analyze the possibility of Thermography aid predictive maintenance to detect mechanical failures in rigid a career unshielded ball bearings. Therefore, eight samples were prepared containing various flaws in the tracks of the inner and outer rings of the bearings. Subsequently, each bearing sample was coupled to a bearing with the shaft and motor, positioned on the inertial table. Then the qualitative and quantitative thermography measurement probes associated with the collection of mechanical vibration data were prepared. The results show that it is possible to see the temperature variations associated with mechanical failures introduced compared to records time-frequency vibration spectrum.

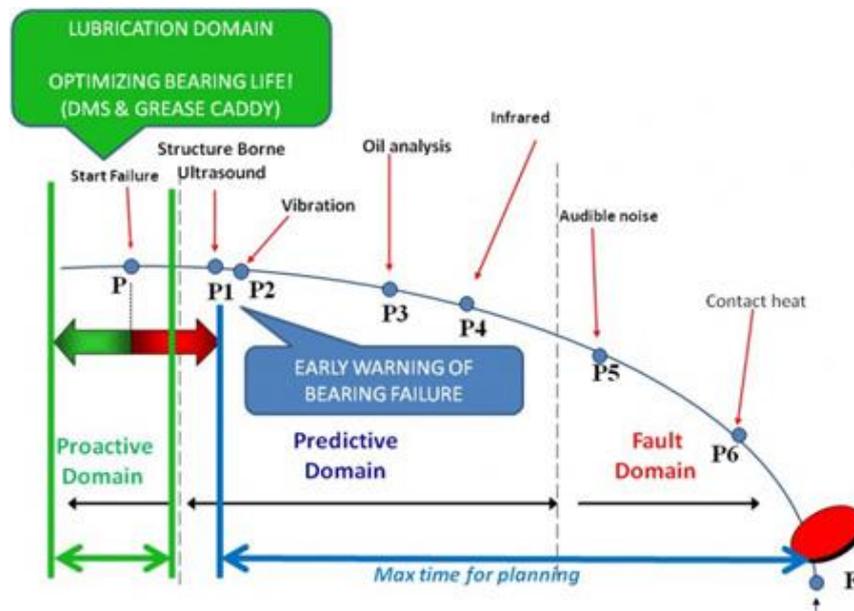
The vibration makes use of the frequency range and their repetitions to diagnose the fault, in case the friction caused by metal-to-metal contact generated by rolling into balls in the defective track. This contact generates energy that accumulate with movement and end up helping to diagnose it. Fig. 1 shows an example of a failure caused by inadequate lubrication and forms planning to detect it.

Fig. 1. Appearance and behavior of a failure and the means to plan their diagnosis. Source - EU Systems.

In Figure 1 to realize the best times to make use of vibration analysis (point P2) and Thermography (point P4). Regular use of these techniques in the field can contribute to reducing costs for corrective maintenance due to the early diagnosis of failure. For example, when a fault is present at an early time, the energy generated by the fault produces electromagnetic waves by thermal radiation. The propagation does not depend on the presence of a physical medium [13]. It is by means of a set of designated particle: photons or quanta and this end to facilitate its extraction and hence its analysis and diagnosis, reducing maintenance costs. But in order to interpret them becomes important to know and manipulate certain variables, namely: wavelength, emissivity, reflected temperature, relative humidity, air velocity, air temperature, camera distance to the object of study, focus , framing and characteristics of the thermographic camera [6], [18]. These variables help to get a good thermogram and facilitate its interpretation. Another important aspect is to determine whether the information in the thermograms should be qualitative or quantitative. Together, in the form of data, such variables help to make a proper diagnosis the technician responsible for the diagnosis of failure.

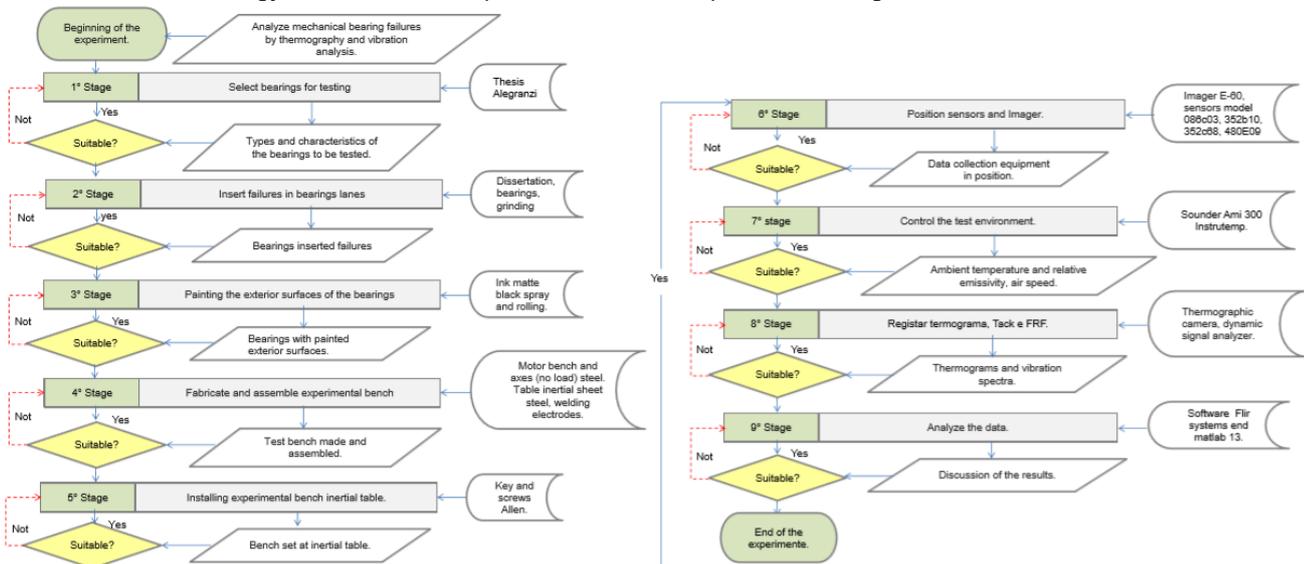
Fig. 2. Flowchart of the Methodology.

With an established need nine activities were developed called steps. Each step were set the expected results and the development of each stage were described the means to carry them out (see Fig.2). With respect to Step 1 designed to select the bearings for the laboratory testing was done using the research work Alegranzi [3]. The intention was to use this work as a reference to discuss the results of this new experiment presented in this research. At work [3] it makes use of vibration analysis as a diagnostic technique while this research is done using thermography. It is compared to the end that was detected by vibration analysis can be detected by means of thermography technique.

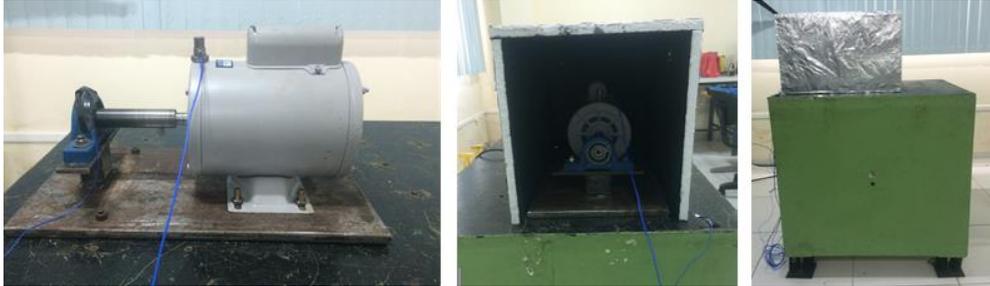
Then, each sample was individually inserted in the housing connected to ½ hp induction motor 1740 rpm and 60 Hz by means of a shaft, which were assembled after positioned on the inertial table. Held this assembly coupled to the sensors (accelerometers) in the bearing Y and Z positions and thermally insulated by a bearing housing with polystyrene painted matt black internally and externally enveloped by aluminum foil. Vide Fig.3.

Fig. 3. Experimental apparatus.

For thermal image recording used the Imager E-60 Flir Systems with reading in the spectral range 7.5 a13 µm a focal length of 400mm. Monitoring of images was carried out over a total time 30 minutes. After stabilizing the system every 5 minutes had become a record thermographic.

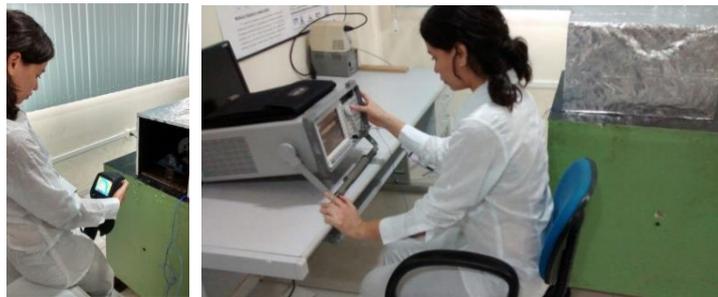
The Table 1 It shows the parameters entered for the thermographic tests. As for the vibration analysis established the 10 second collection time interval, at an acquisition rate of 800 Hz. The procedure was observed by means of the thermogram and confirmed by analyzing the occurrence of vibrations of the inserted failures. These, in turn, were observed from the frequencies 148.0 Hz with an amplitude of the inner races and the outer races 91.3 Hz. See Fig.4.

Fig. 4. Registration thermograms and FRF.

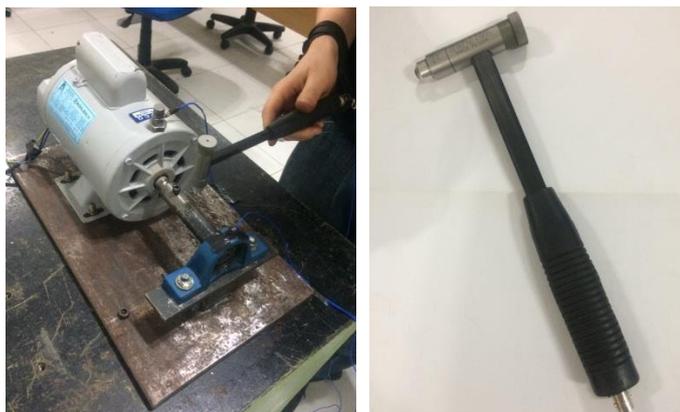
Before starting the analysis of vibration, first we used the hammer 086C03 model impact (impulse force test Hammer), in order to excite the experimental components (shaft and bearing) to accurately reproduce and measure the excitation force of system. The impact hammer has sensitivities ranging from 1 to 100mV / lbf and masses from 0.1 to 5.5 kg, with an amplitude range of up to 22 KN. The goal is to register via the data analyzer the natural frequency of the mechanical elements, see Fig.5.

Fig. 5. Excitation System (left). Impulse force Hammer Test (right).

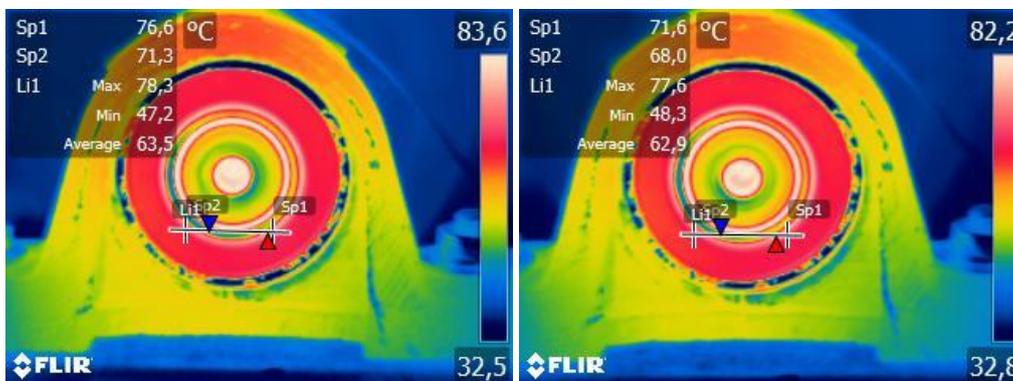
Fig. 6 shows the thermograms obtained in two times laboratory test conducted at no load bearing. In this figure we highlight the so-called temperature measurement points: Sp1 and Sp2, featuring regions with inserted and defect free area defects, respectively. Observe also the measuring line (Li1) designed to determine the lower and higher temperature locations in the bearing under study.

Fig. 6. The thermograms of Sample 1 (SP1 and SP2) respectively.

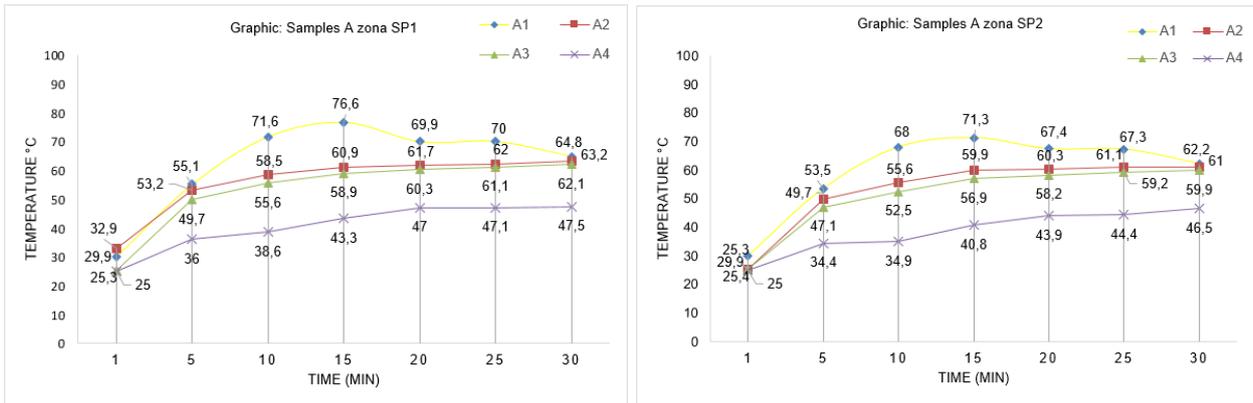
Figure 7 depicts the temperature changes of samples of type A, between the sample A1 and A4, it is possible to realize the heating of the disparity in relation to the types of failures. For a monitoring laboratory, the sample A1 stood out from the others due to the type and size of the fault. This was due to the accumulation of mechanical shock between failure on the track and rolling balls.

Fig. 7. Heating curves of sample A1, A2, A3, A4.

From this information and monitor the temperature at intervals of 5 minutes, the graphs are plotted, shown in Fig. 7 and 8. In the graph of Sample A, Sp1 zone (Zone defective inserted in the inner race) compared to Zone sp2 (defect-free Zone) perceive better temperature changes evidenced in the sample A1, A2, B1, B2. Over time, the thermal conduction process, the temperature will be distributed by the tracks of bearing and the bearing causing the temperature to drop and stabilize. The best results fault detection in these experiments were observed in twenty (20) first few minutes of operation of the equipment, that is, in the preheating phase the bearing.

An important aspect to highlight regarding the differences between the heating curves shown in Fig. 7:08 concerns the size of the inserted fault and the path traversed by the rolling balls. Failure 1 mm (A4 and B4) allow the balls to pass over it without causing significant impact recording lower heating temperatures. Now, when the balls pass through failure 3.5 mm (A1 and B1) record length is greater impacts translating in greater heating in the analysis region, see Fig. 9.

The graphs (Figs. 7 and 8) of heating curves show the variation of the studied areas temperature. As the fault is inserted on sp1 peaks up to 5.1 °C in samples A1, A2, A3 and A4 recorded peaks of 3.1 °C, the samples B1, B2 recorded maximum thermal variation of 3 °C and 2.7 °C on average for B3 and B4, as thermograms of FIG. (s) 10 and 11, demonstrate that these measurements the thermography as may assist in fault diagnostics.

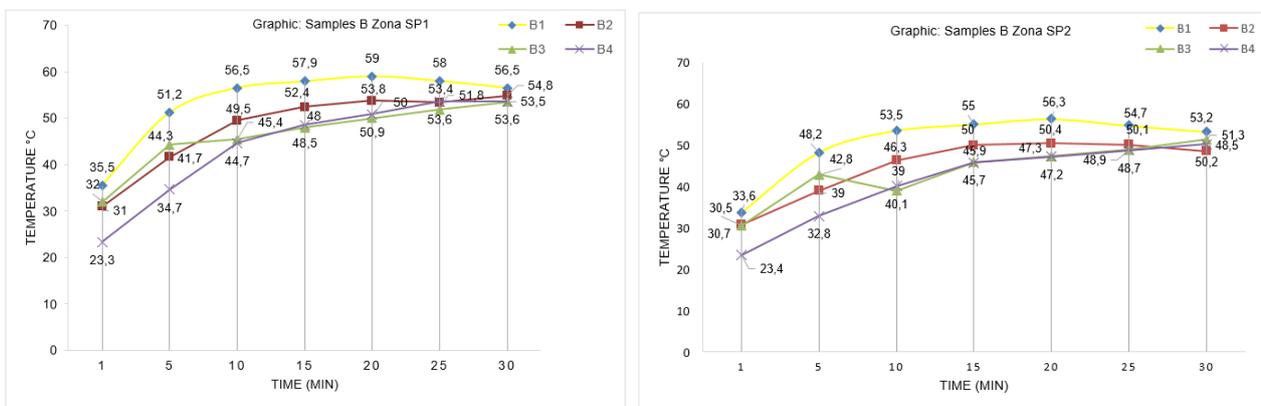
In samples of type B were not marked variations in the curves observed, but it was possible to sense temperature changes when compared to data from Sp1 Zone (Zone with insertion defects in outer race) with data from the Sp2 Zone (Zone free from defects), see Fig. 8.

Fig. 8. Heating curves of sample B1, B2, B3, B4.

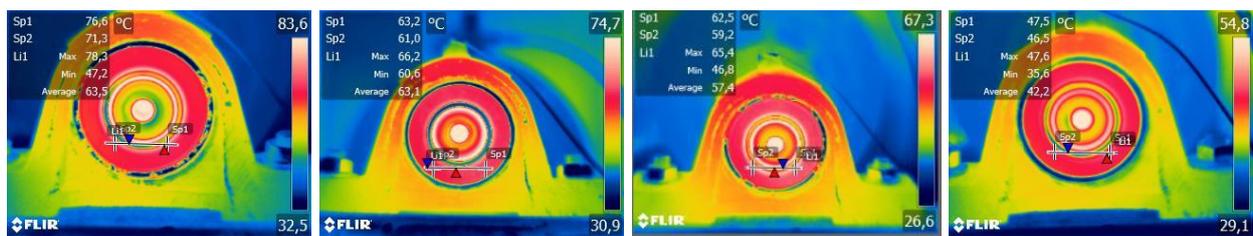
Fig. 9. Thermograms of samples A1, A2, A3 e A4.

Both figures as Fig.9 to Fig. 10 are shown the temperatures evidenced in thermographic records of the sample zones in SP1 and SP2. The thermograms are referred to the last moment of the experimental thermal record, followed by location and identification of failures and temperatures measured.

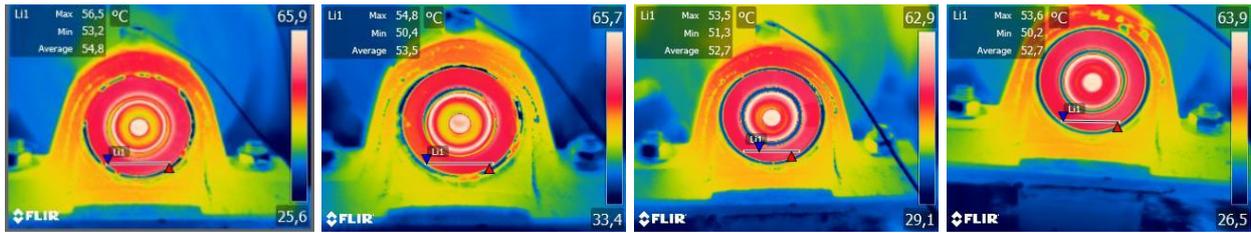
Fig. 10. Thermograms of samples B1, B2, B3, B4.

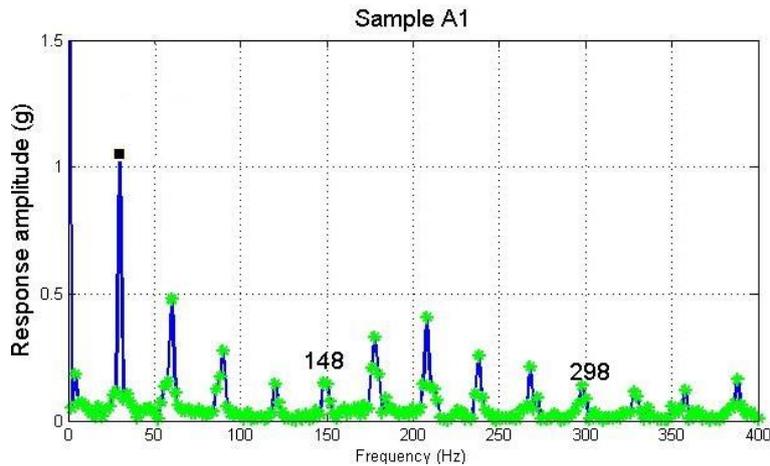
Fig. 11. Vibration spectrum Sample A1.

In figure 11 and 12 presents the vibration spectra of samples A1 and B1 applying the FFT on these signals, we obtain the frequency spectra. Using the failure of equations in bearings for defects in the inner race and outer Eq.(1) and Eq. (2), We found some reference frequencies, the experimental test. To the inner race defects it was confirmed the expected oscilação of 148Hz, since the outer race to the expected frequency was 91,3Hz, and the experimental result was 90Hz, very close to the desired value. However, when considering a rotating element as the bearing, the periodicity, the resonance and the frequency amplitudes recorded in the FFT spectrum, they are decisive for the proof of fault on vibration analysis.

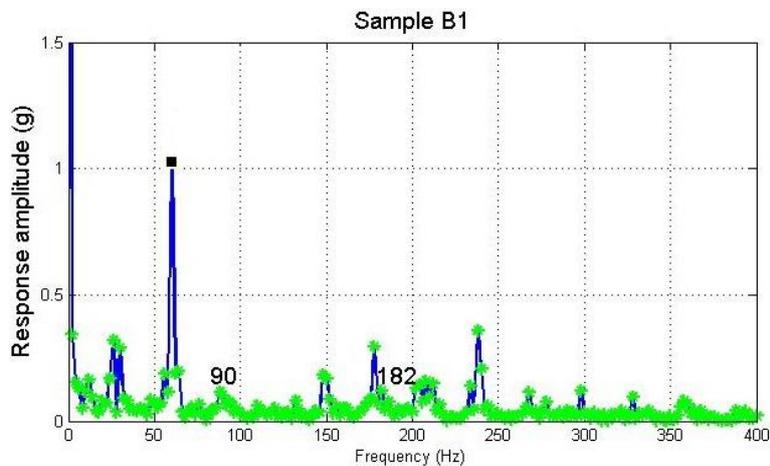
Fig. 11. Vibration spectrum Sample B1.

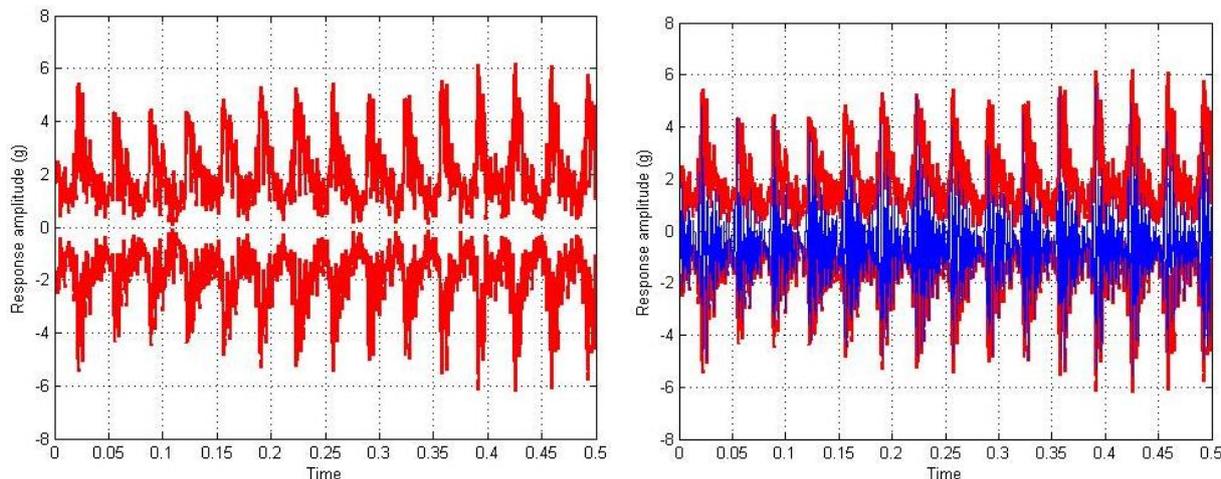
The envelope spectrum (Fig. 12 and 13) are all clearly visible harmonic DPFO, DPFI with spaced sidebands, which arise in the spectra due to a modulation of the signal. These sidebands ("sidebands") on the vibration signals arising defective bearings around a resonance frequency.

Fig. 13. Graphics on the envelope time A1.

In vibration analysis using the FFT, we sought the frequency range provided in the experiment. The FFT analyzes the inconstancy in the frequency range of peaks, as when a bearing is in perfect condition system arousal levels are constant, when this occurs there is no fault indications in the system and the use of envelopes (see Fig. (s) 13 and 14).

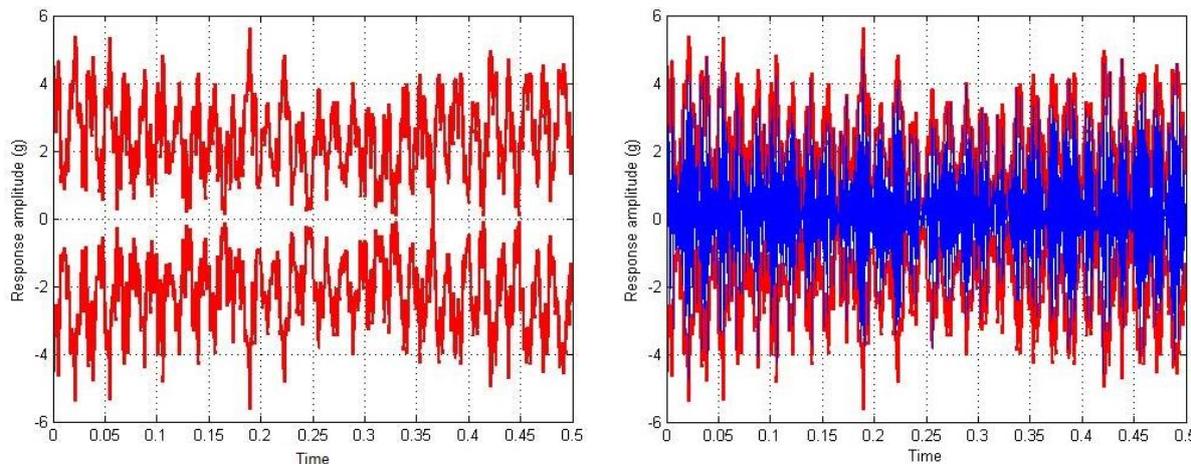
Fig. 14. Graphics on the envelope time B1.
