Applicability analysis of active IR thermography and selected signal processing methods for technical conditions assessment of bridge elements

L. Różański* and K. Ziopaja**

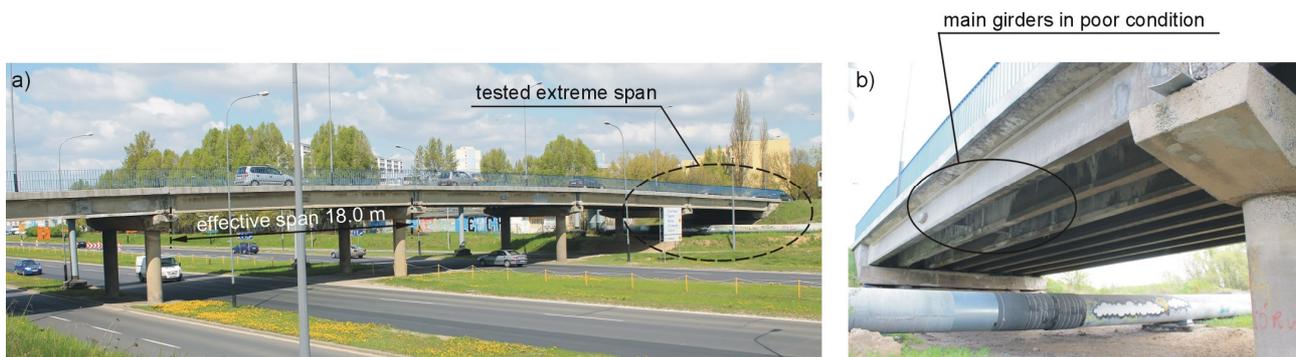
Fig. 1. Partial view of the viaduct: a) marked span, which has been tested with the use of an infrared camera, b) tested span from the bottom of

The abutment (shown in Fig.1) is built of two reinforced concrete columns of diameter of 90 cm which are combined with a massive cap, two wing walls and a back wall. The cap is partly covered by the ground of embankment. The WBS beams have been rested on the cap using tangential steel bearings. There are no expansion joints between concrete span and the back wall of abutment. The typical shape of the longitudinal inclination of the pavement on the structure caused that the substantial amount of rainfall flows in the direction of the analysed abutment. Together with the damaged waterproofing layer this inclination has a very negative influence on the technical condition of the edge pier as well as on some parts of span.

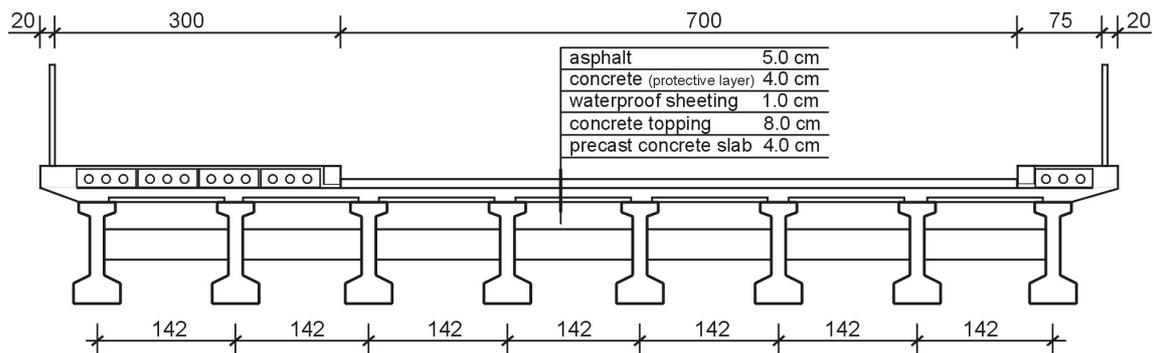
Fig. 2. Schematic cross-section of the viaduct

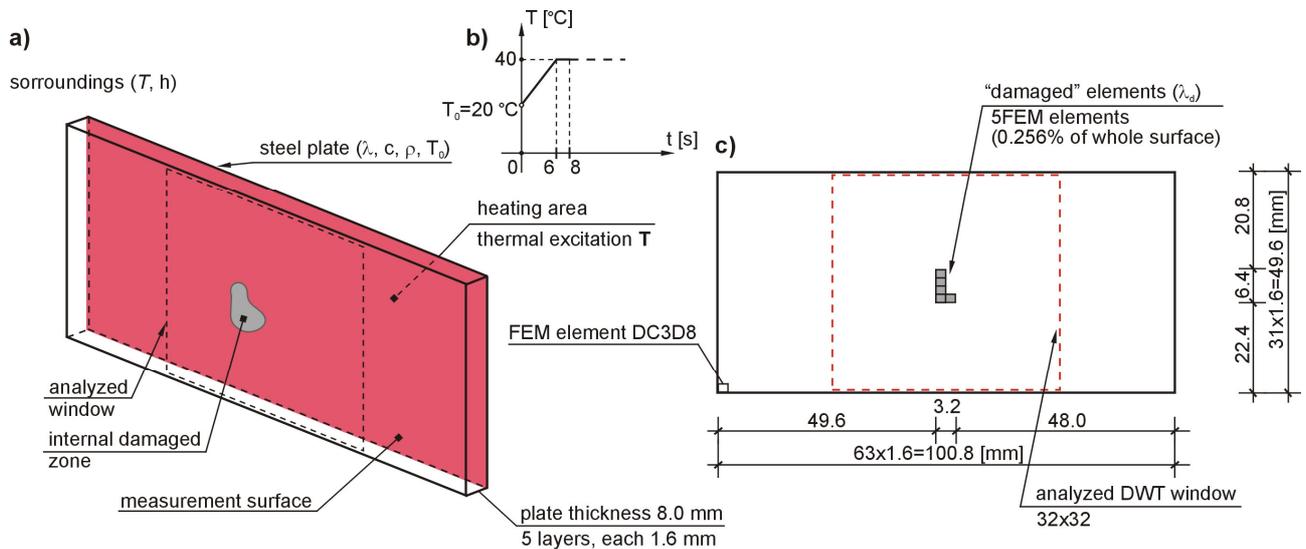
Fig. 7. Damage identification procedure in homogenous 3D structure (Example 1):
 a) model of system
 b) thermal excitation model (Dirichlet boundary condition)
 c) FEM 3D model with damage zone

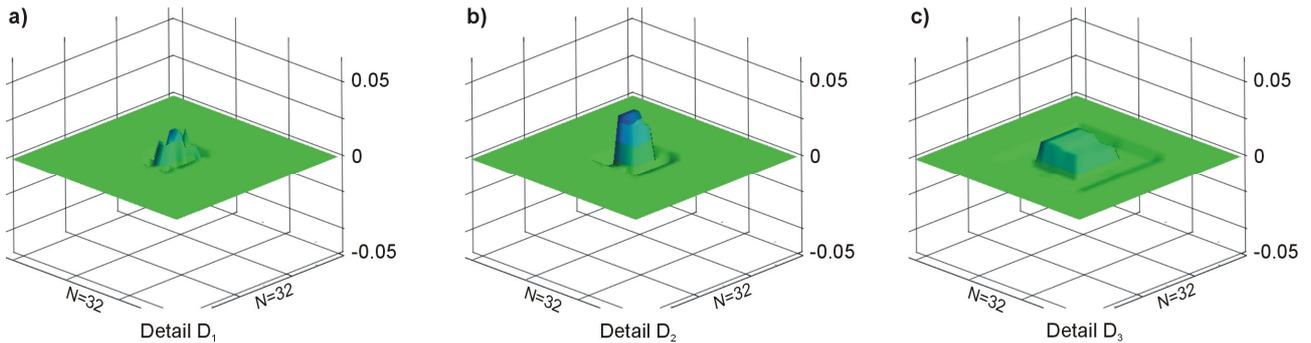
Conducted analyses of numerical heat transfer and wavelet analysis of the temperature measured on the surface of the sample, lead to the following conclusions. Due to the advantageous properties of the wavelet analysis detection of area with different thermal conductivity inside the sample is possible. The effectiveness of damage detecting depends on its size relative to the depth of the surface, on which the temperature measurement is carried out, on environmental conditions and on the parameters of the heat pulse. The measurement time does not play an important role. The simple Haar wavelet and some of the Daubechies wavelet family proved to be the best for visualization of the defect (Fig. 8).

Fig. 8. Graphs of the 2-D DWT of temperature field using Haar function, time=2.14 s:
 a) detail D_1 , b) detail D_2 , c) detail D_3

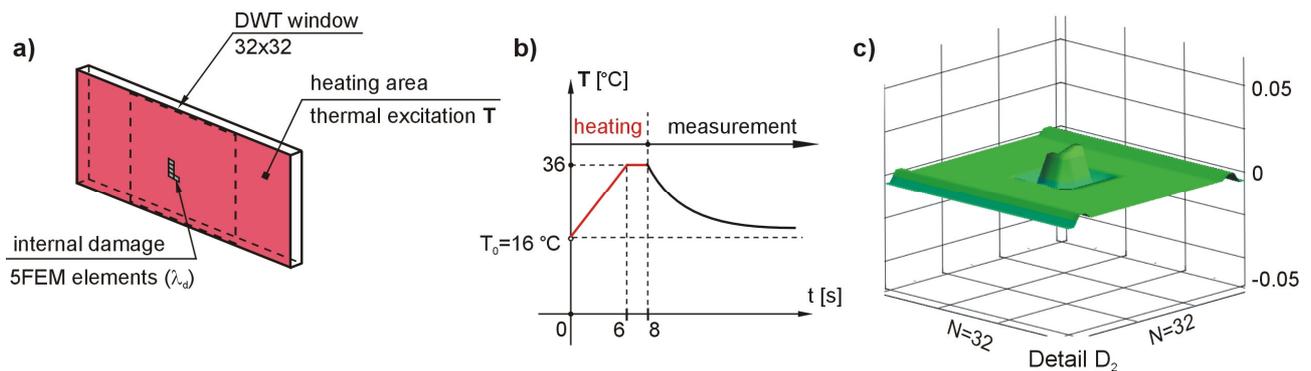
The second example differs from the previous one the parameters of heat excitation (the other surface is heated and thermal input is different in nature - Fig. 9b). Additionally, a different value of thermal conductivity reduction in the area of the defect (50% - $\lambda_d = 25 \text{ W/(m}\cdot\text{K)}$) was assumed. The temperature recording time plays an important role. Cooling of previously heated surface of plate due to natural convection (Henkel boundary condition; Eq. 1), results in rapid disappearance of local temperature changes generated by the defect. With time the chance to locate damage decreases (Fig. 10). Damage detection by analyzing the temperature distribution of the element surface requires precise and appropriately strong heat source and a camera with possibly high recording frequency of complete thermal images. Numerical analyzes also show the sensitivity of damage detection when noise is added to the recorded temperature signal.

Fig. 9. Damage identification procedure in homogenous 3D structure (Example 2):
 a) model of system
 b) thermal excitation model (Dirichlet boundary condition)
 c) graph of the 2-D DWT of temperature field using Haar function, time=0.2 s, detail D_2

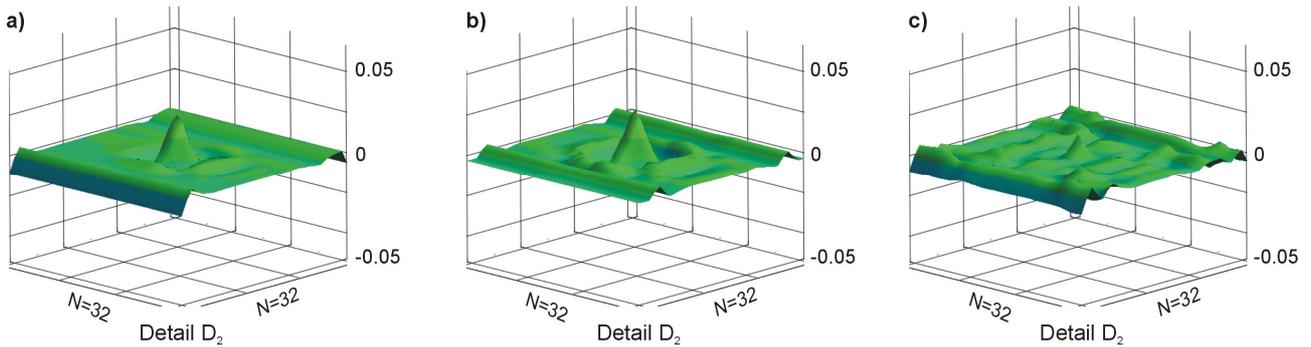
Fig. 10. Graphs of the 2-D DWT of temperature field using Daubechies 6 wavelet, detail D_2 :
 a) time=0.2 s, b) time=0.5 s, c) time=1.3 s

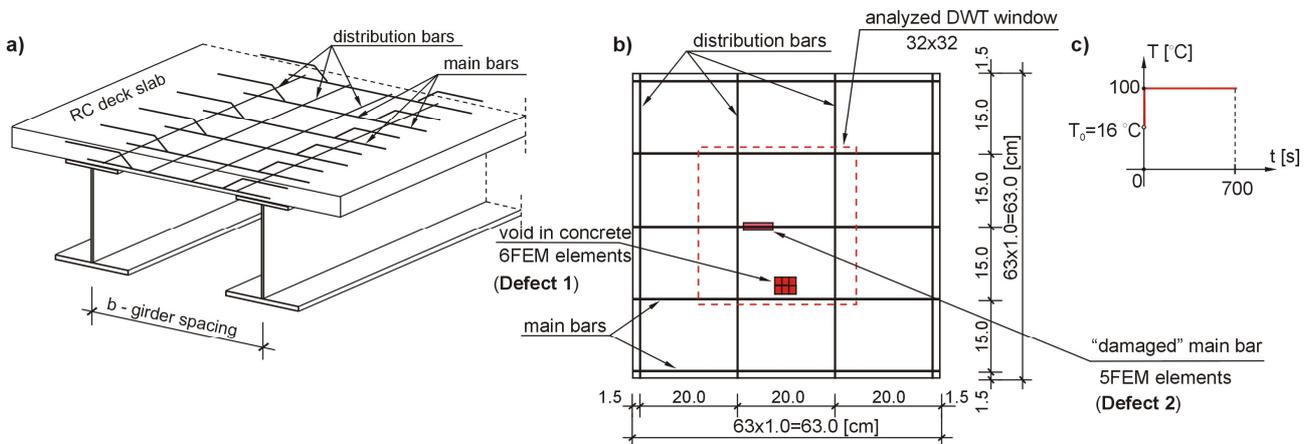
A new class of problems is faced when the structure is non-homogeneous, since the disturbances of the signal can be generated both, by jumps of material parameters and by defects. We will study this issue by the way of an example of a reinforced concrete (RC) plate 63x63x8 cm, shown in Fig. 11. The FEM mesh was generated introducing eight layers: 8x1.0 cm. The parameters of concrete are: density $\rho=2400 \text{ kg/m}^3$, thermal conductivity $\lambda=4.0 \text{ W/(m}\cdot\text{K)}$, specific heat $c=1050 \text{ J/(kg}\cdot\text{K)}$, and for steel: $\rho=7850 \text{ kg/m}^3$, $\lambda=50 \text{ W/(m}\cdot\text{K)}$, $c=450 \text{ J/(kg}\cdot\text{K)}$. In numerical model we neglect thermo-mechanical coupling and local effects in the interface between steel and concrete. The defects are modeled in the form of voids in concrete and corrosion of reinforcement. The location of defects is illustrated in Fig. 11b. Defect 1 is an air void in concrete in second layer and has the dimensions 2.0x3.0x1.0 cm (6FEM DC3D8 elements). Defect 2 takes the form of 5FEM elements in main bar (3-rd layer) with reduced thermal conductivity ($\lambda_d = 5.0 \text{ W/(m}\cdot\text{K)}$).

Fig. 11. Damage identification procedure in non-homogenous 3D structure (**Example 3**):
 a) model of bridge
 b) model of reinforced concrete (RC) plate with defects localization
 c) thermal excitation model (Dirichlet boundary condition)

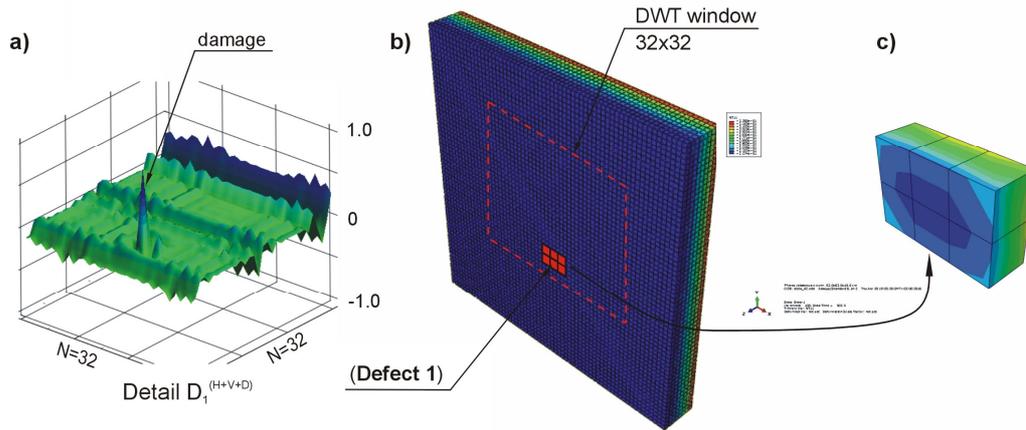
Fig. 12. Results of wavelet and numerical analysis (Example 3, defect 1):
 a) graph of the 2-D DWT of temperature field using Daubechies 4 wavelet, time=504.0 s, detail D_1
 b) FEM model of RC plate with temperature distribution
 c) enlarged area over the place of defect 1

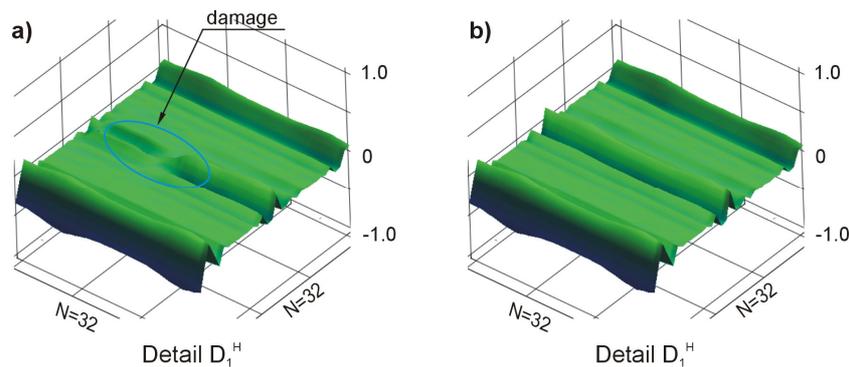
It is much more difficult to detect reinforcement discontinuities due to e.g. corrosion. The simple assumption was adopted that the conductivity of the bar on a small section (5FEM - 5.0 cm) is strongly reduced ($\lambda_d = 5.0 \text{ W/(m}\cdot\text{K)}$). In order to facilitate interpretation of the 2-D DWT graphs the results of analyzes with defect were compared with these without it. It has led to some interesting conclusions. We found that in order to improve detection and localization of defect it is preferable to analyze the individual components of the detail decomposition (Eq. 2) than their sum. A similar conclusion has already been given in [10].

Fig. 13. Graphs of the 2-D DWT of temperature field using Daubechies 4 wavelet, time=504.0 s, (Example 3, defect 2):
 a) graph of detail D_1^H with defect 2
 b) graph of detail D_1^H without defect 2

The temperature distribution in the discrete wavelet analysis is understood as a matrix of dimension $J \times J$. Wavelet which analyzes that signal moves independently along the following rows, along each column and diagonal. Thus the disturbances of DWT (Fig. 13a) at the location of the defect 2, was formed because the defect was oriented transversely to the direction of wavelet movement. In this case, the detail D_1 has only a horizontal component D_1^H . Other components of detail D_1 do not contain any important information about the defect. When we consider all components of the transform signal, it is very difficult to set the location of damage (Fig. 14a).

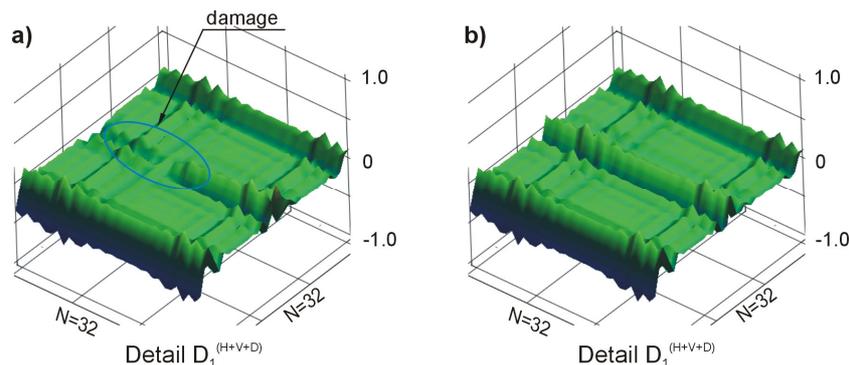
Fig. 14. Graphs of the 2-D DWT of temperature field using Daubechies 4 wavelet, time=504.0 s, (**Example 3, defect 2**):
 a) graph of detail D_1^{H+V+D} with defect 2
 b) graph of detail D_1^{H+V+D} without defect 2
