Towards the use of passive and active infrared thermography to inspect metallic components in the mechanical industry

by S. MAILLARD*, J. CADITH*, D.ESCHIMESE*, H. WALASZEK*, H. MOOSHOFER**, J.C. CANDORE*** and J.L. BODNAR***

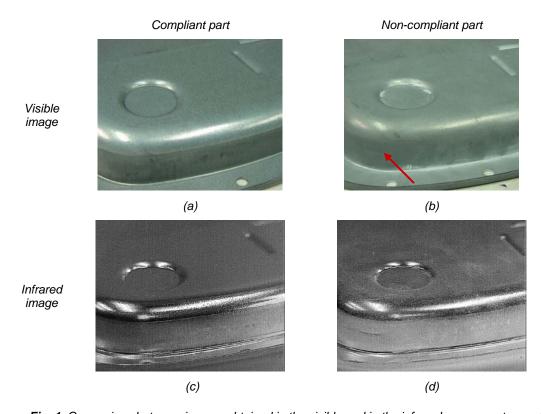
Fig. 1. Comparison between images obtained in the visible and in the infrared range on stamped parts subjected to closed crack apparition

Image obtained in the visible range slightly highlight the presence of the closed crack but during on-line inspection, the detection is disturbed by the presence of a hot lubricant film on the sample surface. In field measurements have shown that thermal images overcome this drawback. On-line inspection should thus be achieved on such images using conventional algorithms for crack detection.

Thermal images were also achieved on compliant and on non-compliant parts. They were compared with images of the same parts obtained in the visible range. Examples are given in the figure 1.

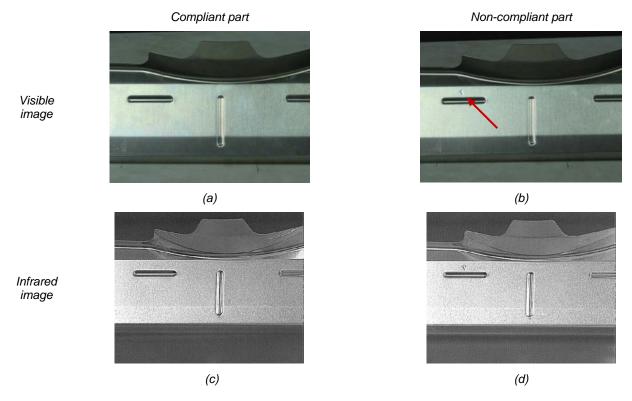
Fig. 2. Comparison between visible and thermal images on stamped parts subjected to surface defect

Whereas conventional vision inspection is strongly dependant on the lighting for bright material, thermal images enable to detect surface even on material usually not considered for infrared thermography because of their low emissivity (aluminium, polished stainless steel, ...).

In figure 2, thermal images are compared with images obtained in the visible range on parts with and without surface defect. These parts are made of stainless steel and covered by the lubricant film layed on the metal sheet during the forming process.

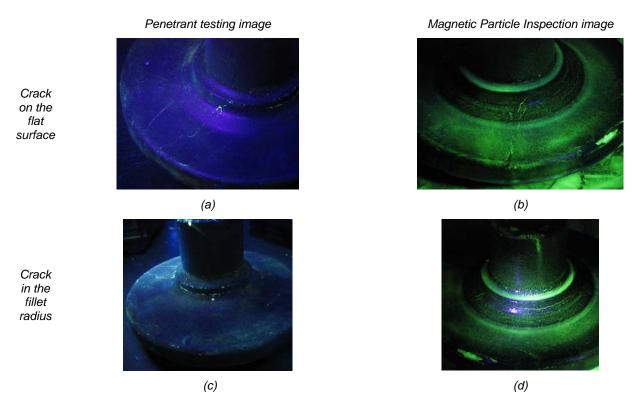
Fig. 4. Images obtained by penetrant testing and magnetic particle inspection on a cracked forged hub

On the figure 4, penetrant testing as well as magnetic particle inspection images highlight indications that correspond to a crack that goes from the flat surface of the hub and propagates in the fillet radius.
