Characterisation of artificial defects in CFRP and GFRP sheets designed for energy applications using active thermography

by C. Maierhofer¹, R. Krankenhagen¹, M. Röllig¹, B. Rehmer¹, M. Gower², G. Baker², M. Lodeiro², A. Aktas², L. Knazovicka³, A. Blahut³, C. Monte⁴, A. Adibekyan⁴, B. Gutschwager⁴

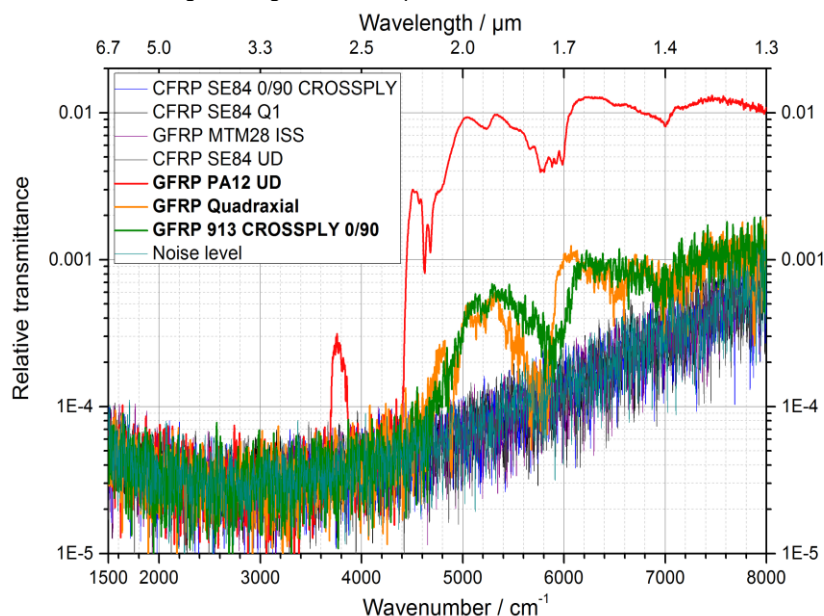
Fig. 1. Relative spectral transmittances of the CFPs and GFPs at 25°C in the wavelength range from $1.3 \mu\text{m}$ to $6.7 \mu\text{m}$

The relative transmittance of the different materials is shown in figure 1. The CFRP test specimens as well as the GFRP test specimen with black pigments (GFRP MTM 28) showed no transmittance in the range from $1.3 \mu\text{m}$ to $25 \mu\text{m}$ whereas the three GFRP test specimens showed some residual transmittance in the range from 1.3 to $2.8 \mu\text{m}$ but no significant transmittance at wavelengths longer than $2.8 \mu\text{m}$.

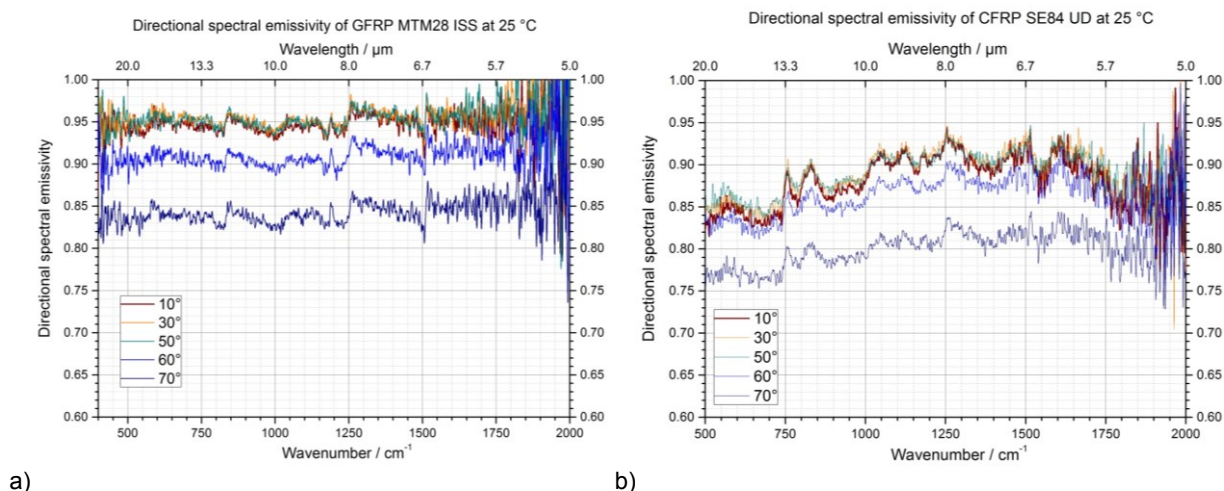
Fig. 2. a) Directional spectral emissivity of GFRP MTM28 at 25 °C under angles of observation from 10° to 70°. b) Directional spectral emissivity of CFRP SE84 at 25 °C under angles of observation from 10° to 70°.

The directional spectral emissivities of GFRP MTM28 recorded under angles of observation from 10° to 70° are shown in figure 2.a. An overall emissivity of about 0.95 at near normal observation and a typical decrease to lower values at larger angles of observation was found. The directional spectral emissivity of CFRP SE84 shown in figure 2.b is slightly lower ranging from 0.83 to 0.94 for near normal observation but also decreasing towards larger angles of observation.

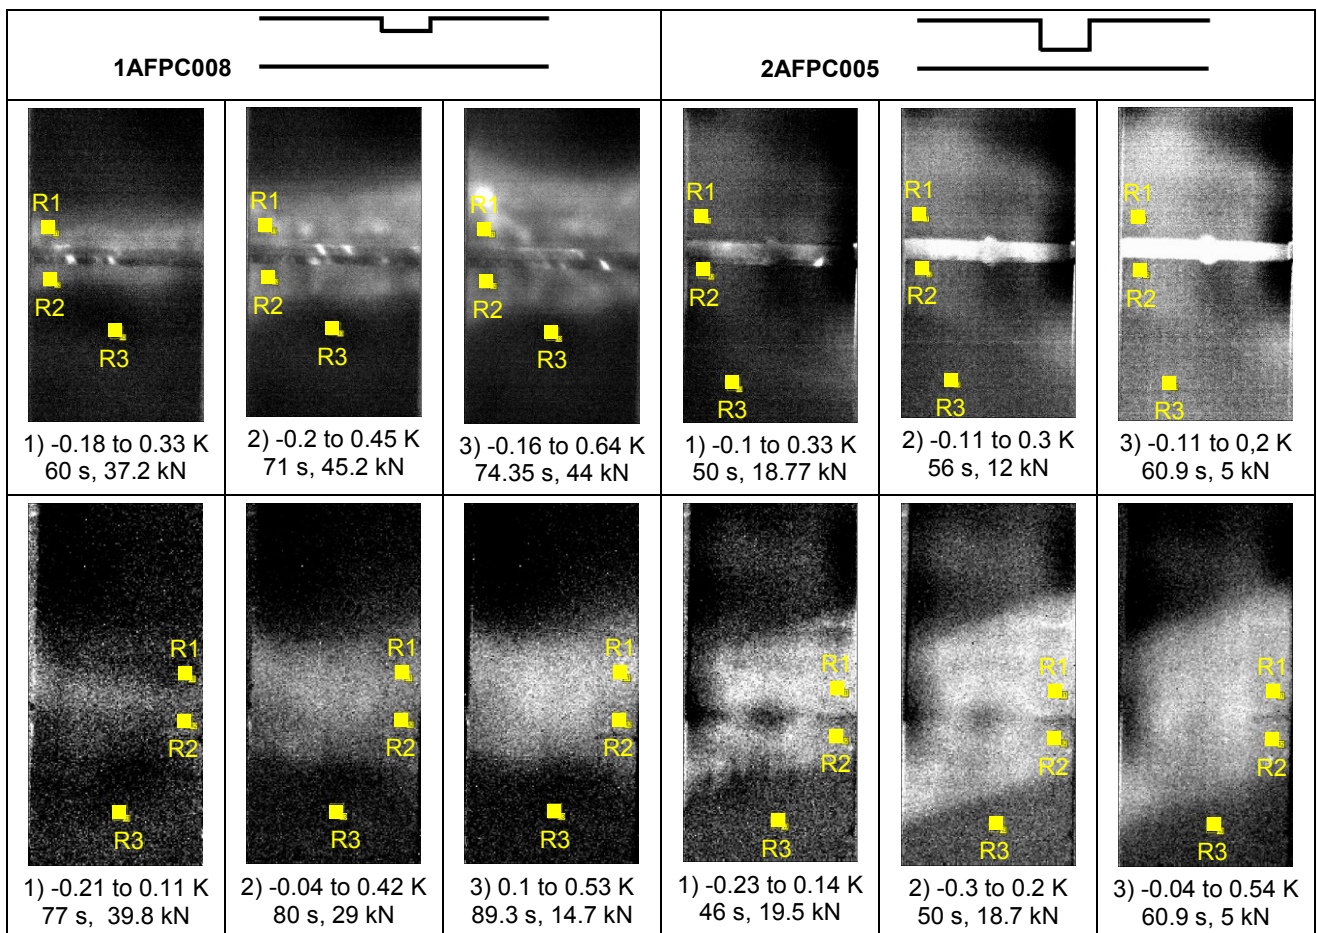
Fig. 5. Thermograms of the back (top) and front side (bottom) of GFRP test specimens 1AFPC008 (left) and 2AFPC005 (right) with a thickness of 5 mm and a remaining wall thickness of 3.5 mm and 1.6 mm at the notches, respectively, recorded at different times during tensile load. Sample 1AFPC008 failed after 71 s, sample 2AFPC005 after 45 s. The time stamps of the thermograms are related to figure 4, middle and right column.

The thermograms of test specimen 1AFPC008 are shown in figure 5 left. This test specimen failed after 71 s at a load of 45.2 kN. Through the whole load cycle, a lot of hot spots were observed related to fibre breaking. Again, two warmer stripes appeared at the edges of the notch. After failure, a large warm area appeared which can be related to delaminations. This area is larger as that of AFPD007, but has the same asymmetry (being wider on one of the lateral sides of the test specimen). Similar to AFPD007, the bottom of the notch appeared warmer at the end of the test (not shown here). At the front side (see figure 5 left, bottom), an increase of surface temperature could only be observed after

failure (please note the different time stamps). At the end of the sequence, the area with enhanced temperature has the same shape as at the back side.

Figure 5 right shows the thermograms of test specimen 2AFPC005, which failed after 45 s at a load of 20 kN. Here, only the thermograms after the failure are shown, as the temperature increase of the area with damage could only be observed after damage. This temperature increase was higher at the front side being closer to the delaminations. The warm damaged area has the shape of a parallelogram, thus the shape was different from the other test specimens. It appeared to be point symmetrically to the middle of the notch. During loading, fewer hot spots due to fibre cracking could be overserved in comparison to the other test specimens.

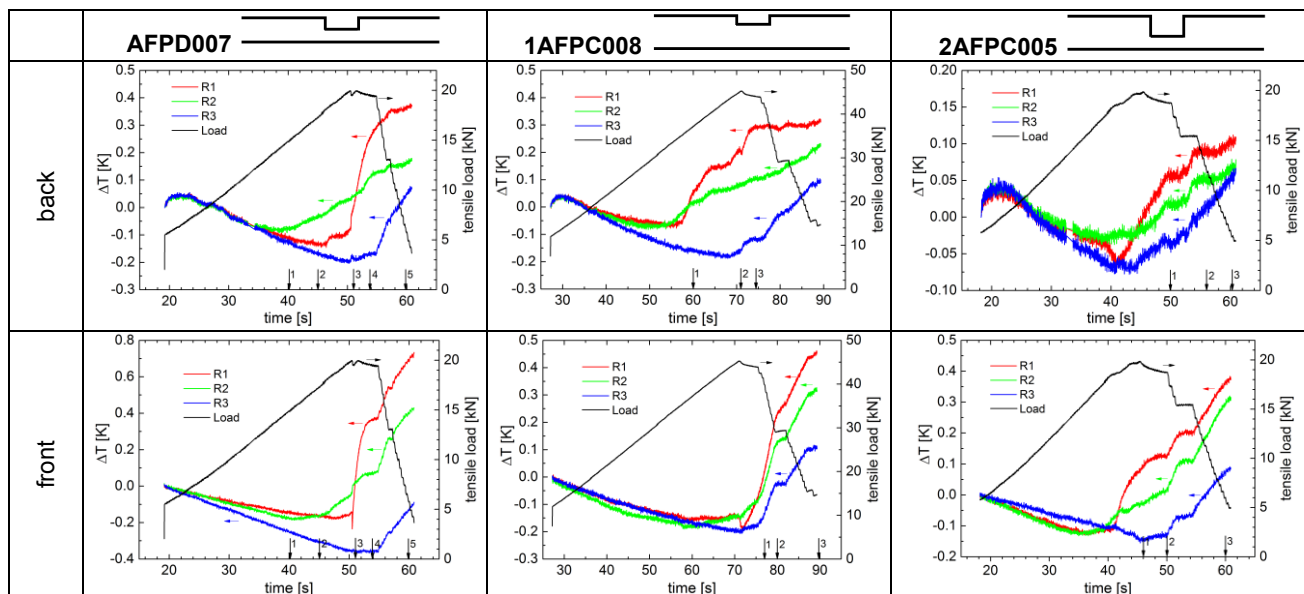
Fig. 6. Temperature (red, green and blue lines) and tensile load (black line) as a function of time during tensile load of the three GFRP test specimens. The three temperatures lines are belonging to different positions on the samples, which are marked in figure 5 and 6, and were recorded at the back (top) and front side (bottom).

By comparing the temperature as a function of time diagrams in figure 6, the following points can be summarized:

- In all diagrams a cooling down of the surface of the test specimens due to the thermo-elastic effect with increasing time and thus increasing load and displacement could be observed [9, 10]. Especially for the non-damaged area R3, the cooling down occurred until the failure of the samples.

- A temperature increase due to plastic deformation first starts at area R2 for all samples and always before failure. Afterwards, the temperature at area R1 rises relatively fast before failure at test specimens 1AFPC008 and 2AFPC005 and at the moment of failure at test specimen AFPD007. After the failure, also the temperature at area R3 was rising, but always with a delay in comparison to areas R1 and R2.

- At area R1 always the highest temperature rise, at R2 a medium temperature rise, and at R3 the lowest temperature rise was observed.
- At test specimen AFPD007, the temperature rises at the back and front surfaces were observed at the same time. This leads to the conclusion that the first damages are occurring at the middle of the sample, i. e. at the depth of the notch. The temperature increase at the front surface was higher and shows a second step in comparison to the temperature rise at the back surface. Probably further damages (and most probably partial delaminations) positioned closer to the front side occurred later during failure.

- At test specimen 1AFPC008, the temperature rise at the front side occurred considerably delayed to the temperature rise at the back side. Thus the delaminations might be positioned much closer to the back side (with the open notches) according to the position of the bottom of the notch. Again, the temperature increase at the front side was slightly larger than at the back side, probably due to further later damages located closer to the front side.
